Handshake Partnership Program Final Project Close-Out Report

1. Fiscal Year Selected as Winning Project: 2015
2. Name of Corps Project/Lake: Smithville Lake
3. District / Division of Corps Project/Lake: Kansas City District, Northwest Division
4. Handshake Project Name: Erosion Reduction & Sedimentation Prevention Project
5. Amount of Handshake Funds remaining: \$0.00
6. What has been accomplished? Please provide photographs; before, during, and after!

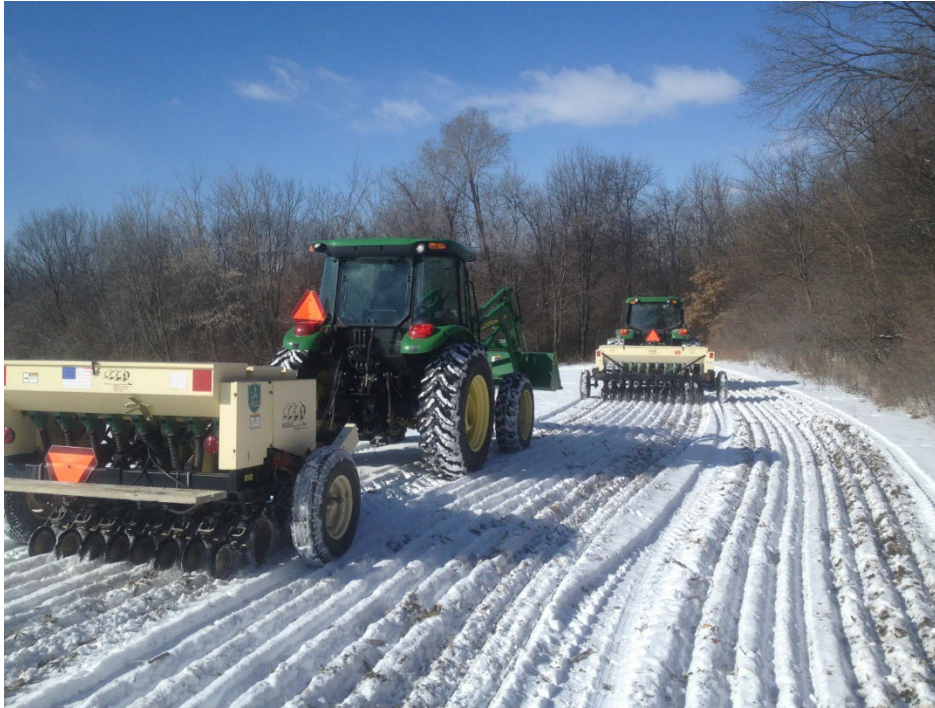
Warm season grass planting of 52 acres during the winter of 2015. USACE employees and tractors were used in conjunction with grass drills provided by the Missouri Department of Conservation. The warm season grass mix will reduce erosion and provide ample habitat and food sources for a variety of wildlife.

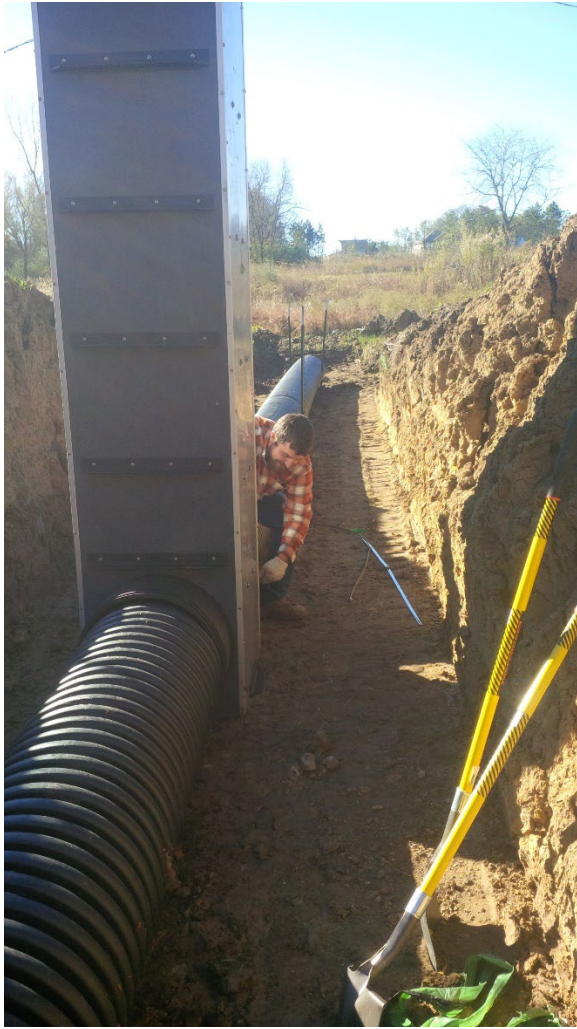
Left, Mitch Green, USACE maintenance employee attaches the inlet pipe to the water control structure at the wetland located at Public Access 31 on Smithville Lake. The existing structure had failed and no longer functioned to control the water levels. Below, USACE employees continue the backfill and compaction process to ensure a proper installation of the structure. 3 water control structures were replaced with this handshake agreement.

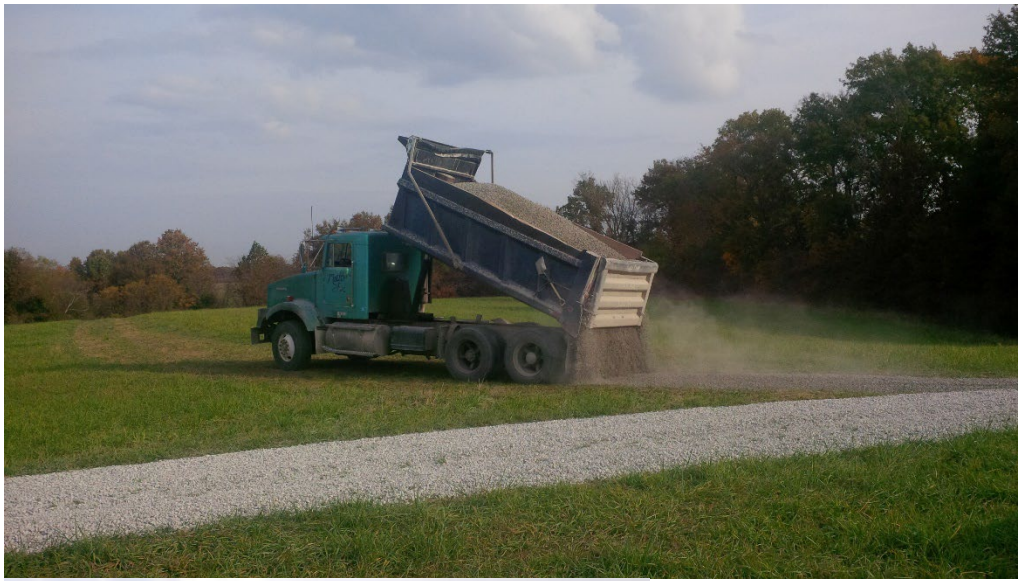
Above, gravel service drives were added to the wetlands and ponds to promote access to the areas by the public. Left, 10 duck nesting tubes or hen houses were installed on the 3 wetlands to promote nesting success. They were created by the Boy Scout Troop and installed by Park Rangers. Nesting success is boosted by more than 60% with the use of hen houses.

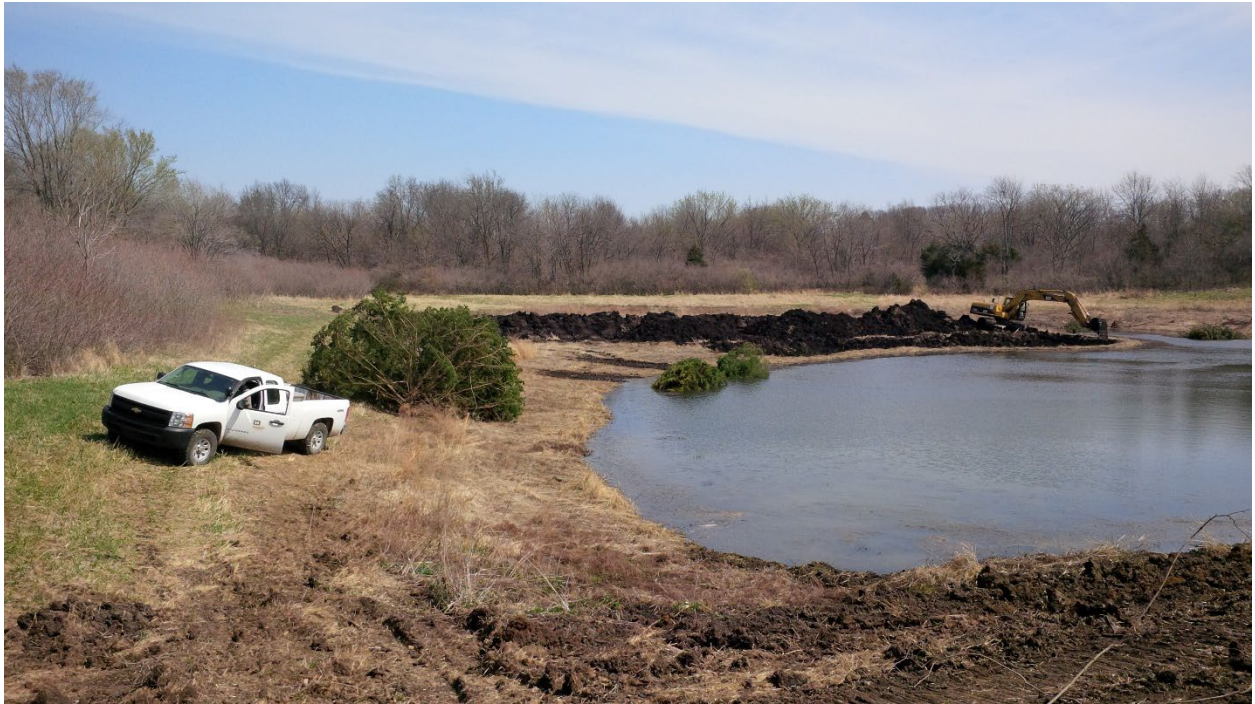
Above, USACE Park Rangers drag cedar trees to the waters edge to be installed for fish habitat as a contractor works in the excavator to dredge the pond and install a fishing pier. 2 of the largest ponds on Corps property were rehabilitated with this handshake agreement. Below, a contractor removes trees from a pond dam that is overgrown, damaged by muskrats and leaking water.

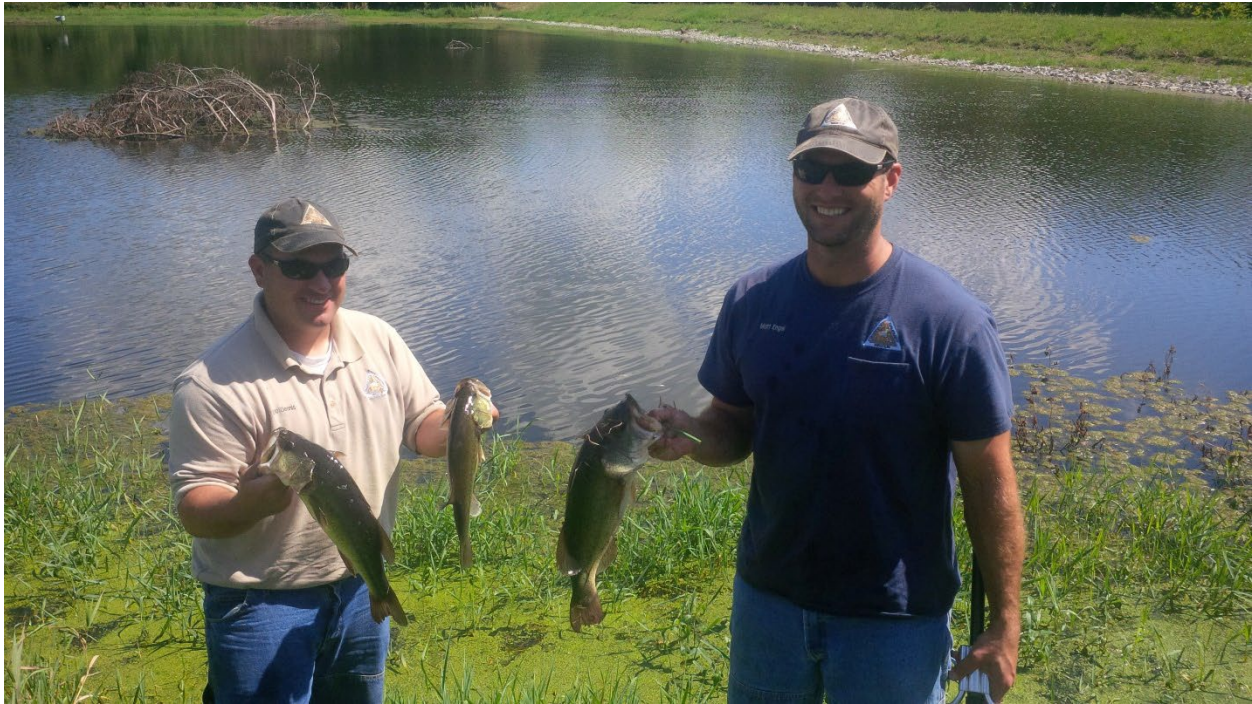
Above, Large mouth bass are one of the species that were stocked in the 2 rehabilitated ponds. The Missouri Department of Conservation stocked over 500 fish. Below, a contractor installs massive oak and cedar trees into the ponds for fish habitat. The pond dams were cleared of trees and the largest of the trees were reused for fish habitat.

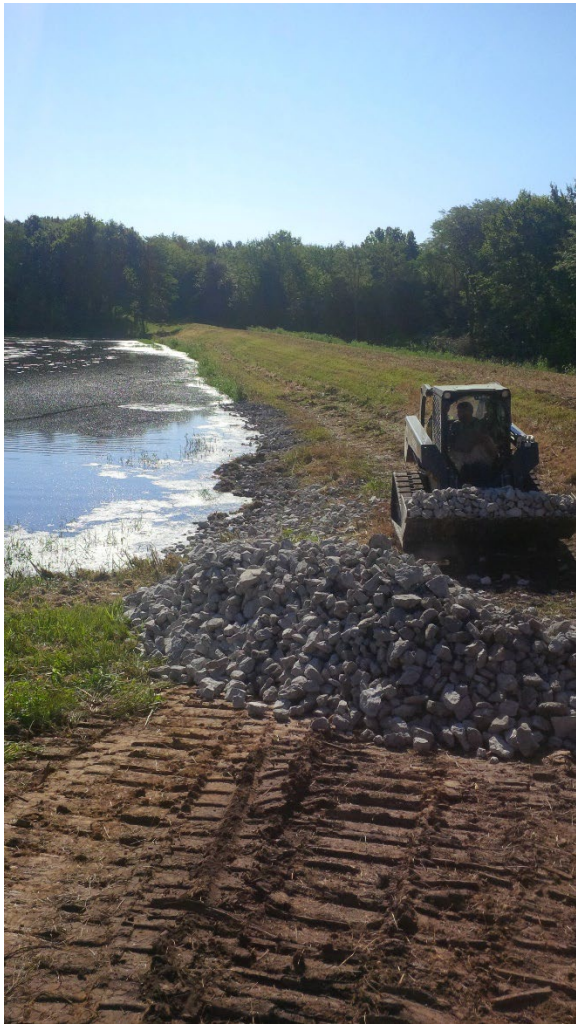
Left, USACE staff install 8 inch gabion rock along the waterline to protect the dams from muskrat damage. Below, USACE maintenance staff armor the shoreline by the Visitor Center with 8-20 inch rip rap. The rock quarry's dump trucks back right up to the edge of the eroded shoreline.

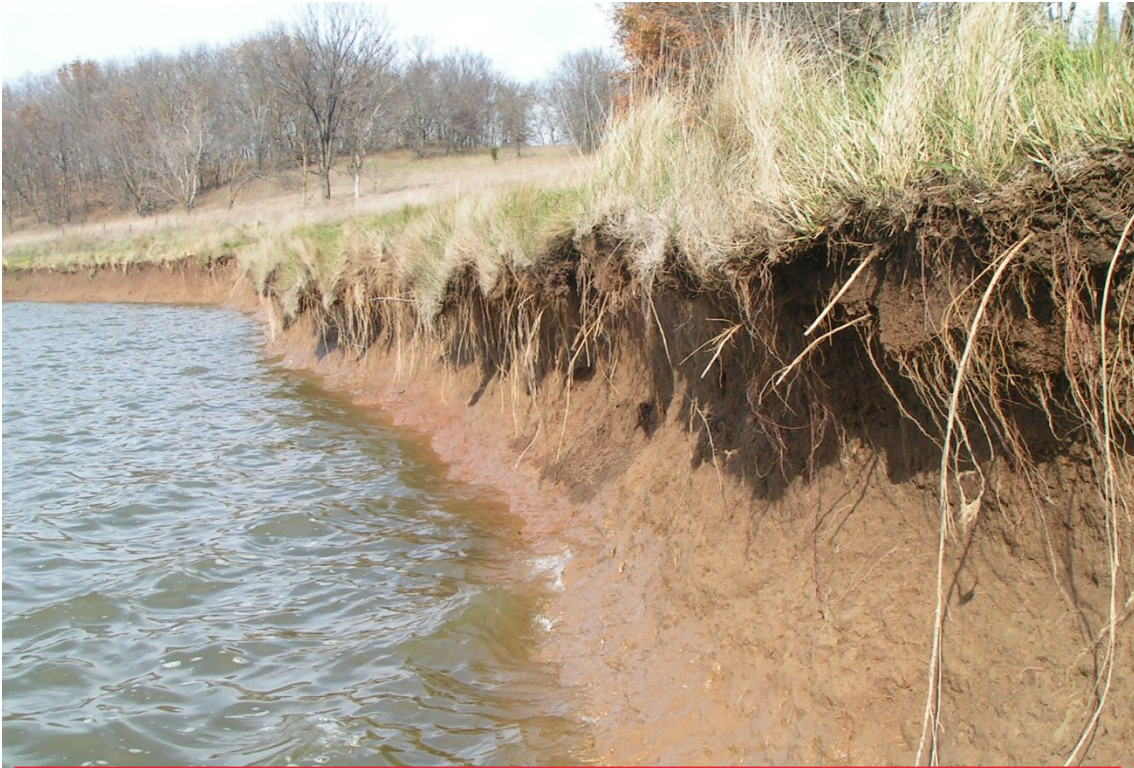
Above is a before picture of the heavily eroded shoreline at Sailboat Cove. The water level is at normal pool and continues to erode the base of the cut bank. Below, shows the placement of 6-14 inch rip rap along the shoreline of Sailboat Cove. The rock quarry's dump trucks back right up to the shoreline and dump 30 tons of rock at a time. These trucks weigh in at 80,000 pounds, so the ground conditions must be dry or frozen to get them off road.
