Condition Assessment Quick Guide for Asphalt Roads

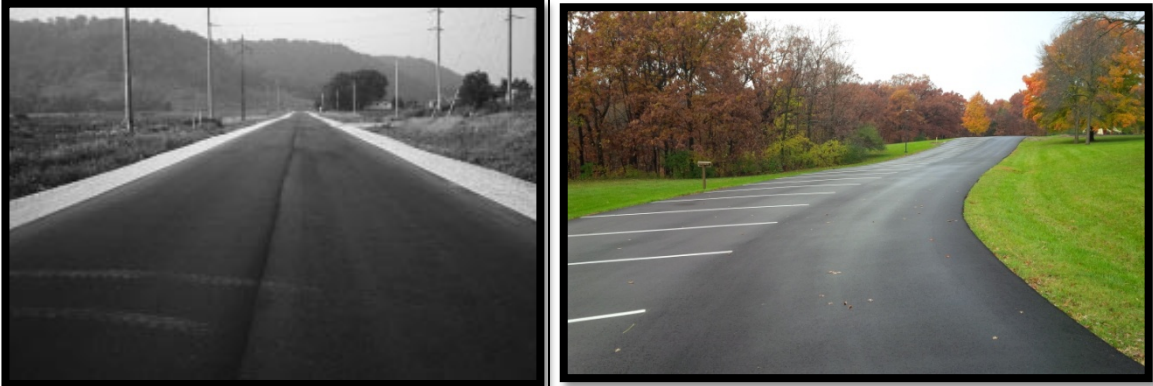
USACE FCI Score	OCA Grade	PASER Score	Description	Images
<p align="center">7 Excellent</p>	<p align="center">A</p>	<p align="center">10-9</p>	<ul style="list-style-type: none"> • New Construction, recent overlay or like new • No defects

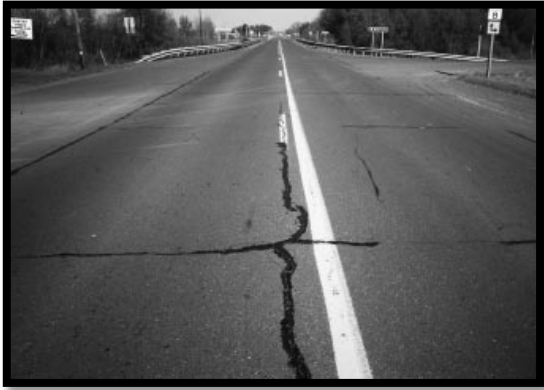
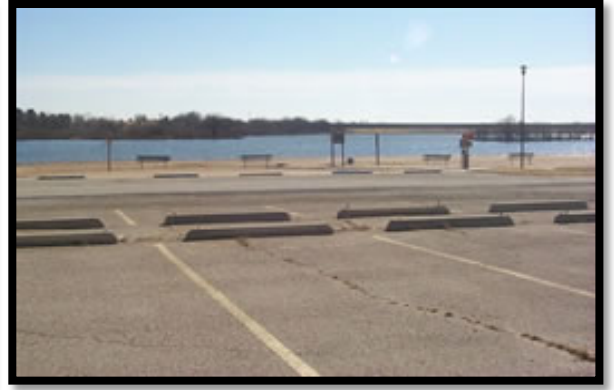
USACE FCI Score	OCA Grade	PASER Score	Description	Images	
5 Good	B	7-6	<ul style="list-style-type: none"> • Longitudinal crack on paving joint open no greater than 2/1" • Transverse cracks 10-40' apart; Transverse cracks open up to 1/2". • Initial block cracking; blocks are large and stable • First signs of wear. Little to slight erosion, raveling. Slight polishing or flushing • Few if any patches in good condition

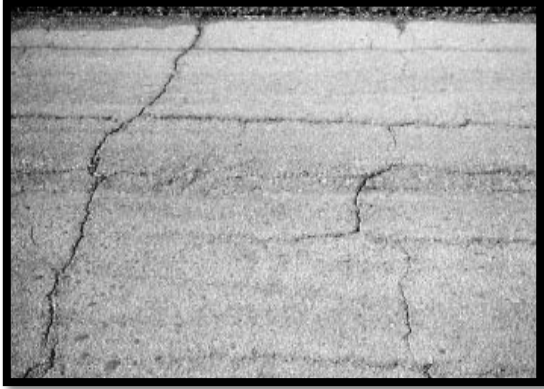
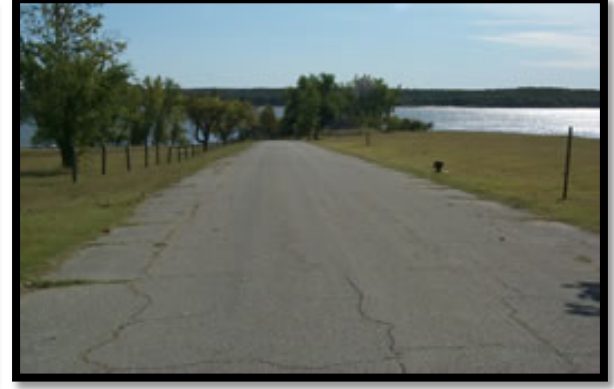
4 Good to Fair	B-	5	<ul style="list-style-type: none"> • Longitudinal cracks >1/2". • Transverse cracks >1/2". • Secondary cracks (crack raveling). < 50% of block cracking. • First signs of longitudinal cracks at edges. • Sound structural condition, patching/ wedging in good condition, moderate raveling and extensive flushing & polishing.

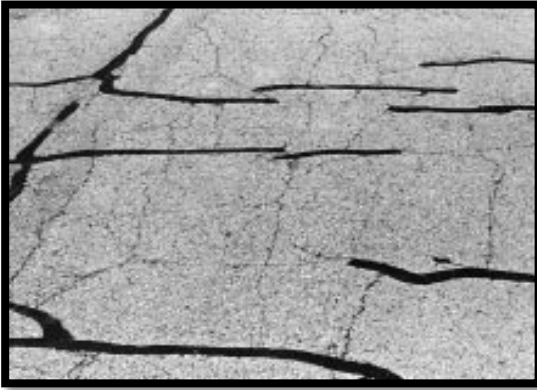
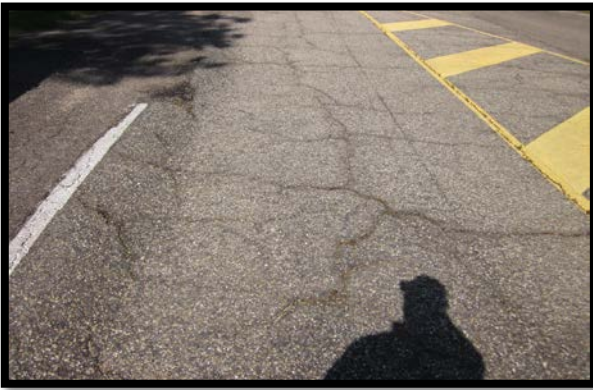
USACE FCI Score	OCA Grade	PASER Score	Description	Images
3 Fair	C	4	<ul style="list-style-type: none"> • Longitudinal cracking in the wheel paths. • Rutting 1/2" - 1" deep. 50% block cracking. • First signs of structural weakening -severe surface raveling, multiple longitudinal & transverse cracks with slight crack erosion, and patching in fair condition

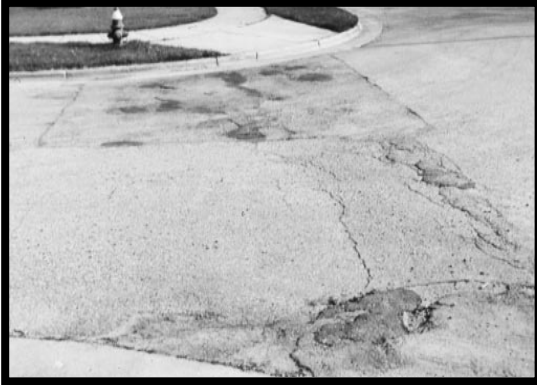
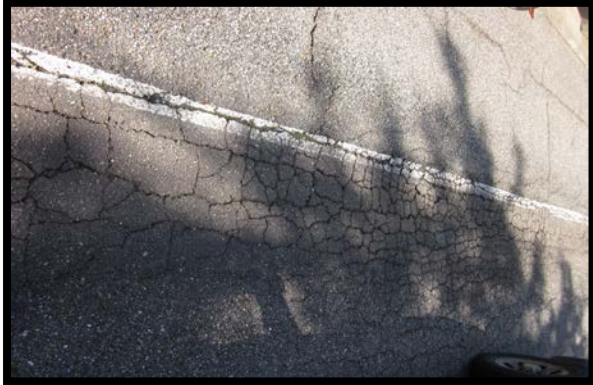
2 Fair to Poor	C-	3	<ul style="list-style-type: none"> • < 25% alligator cracking (first signs). Moderate rutting • 1" - 2" deep. • Severe block cracking. Longitudinal & transverse cracks showing extensive crack erosion. Occasional potholes. Patches in fair/poor condition
