A REVIEW OF CARRYING CAPACITY AND A FIELD STUDY OF PARK MANAGERS'
TECHNIQUES TO MINIMIZE THE IMPACTS OF RECREATION USE AND OVERUSE
ON SOILS RESOURCES

SPECIAL PROBLEM

A paper submitted to fulfill the
requirements for GEOS 476
at Morehead State University

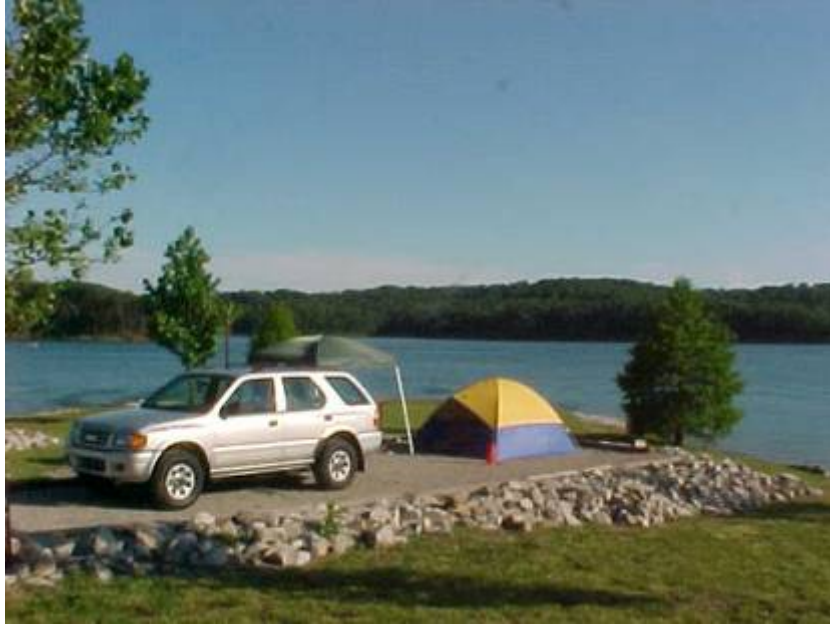
Figure 1. Typical hardened pad provided for COE campsites and picnic areas, with a fine crushed stone surface. This campsite at Moutardier Campground, Nolin River Lake, KY also has a riprap border to prevent erosion when the lake level rises

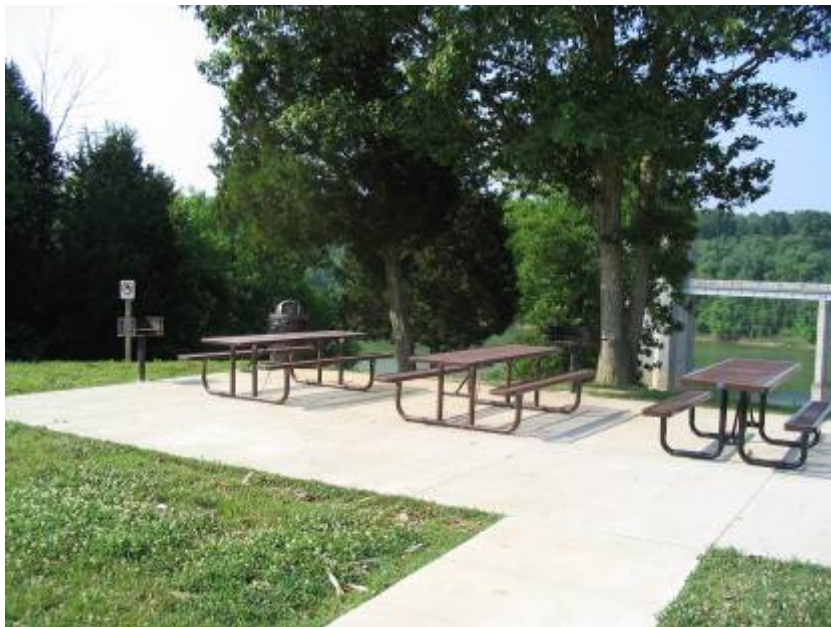
Figure 2. Taylorsville Lake, KY. COE picnic sites with concrete impact zone. This option provides access for persons with disabilities.

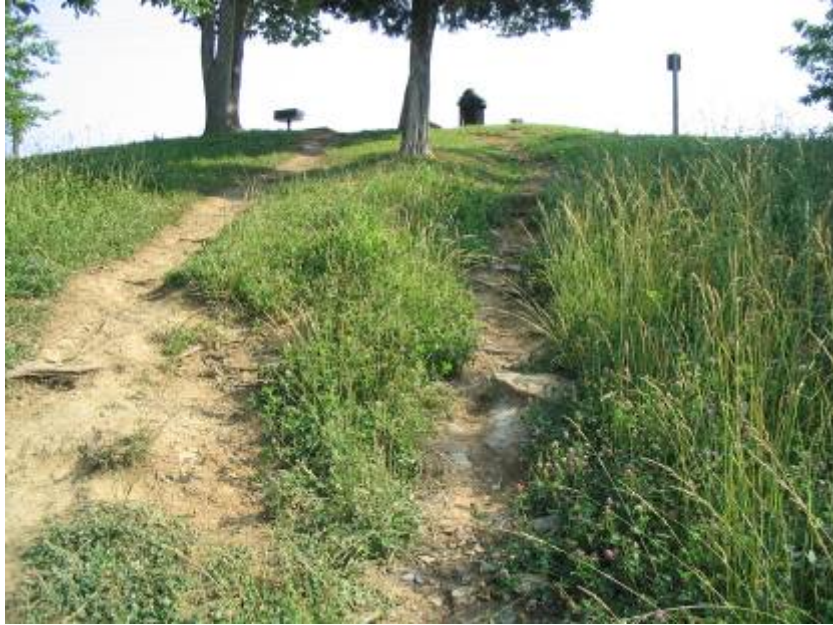
Figure 3. Taylorsville Lake, KY. Erosion on trail created by bank fishermen just upstream of the right abutment of Taylorsville dam.

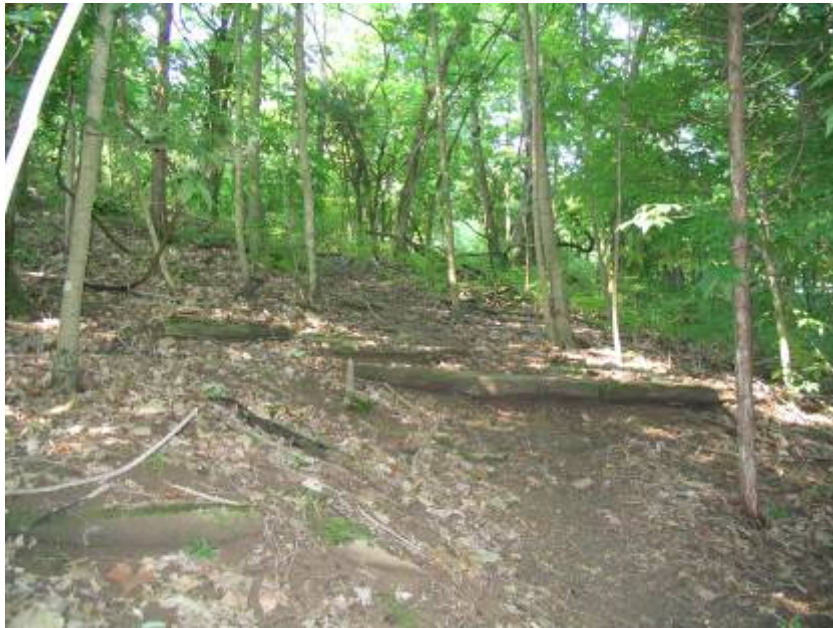
Figure 4. Taylorsville Lake, KY. This steep section of interpretive trail does not have erosion problems, but safety issues arise due to being very slick when wet. Installation of a hand rail is recommended.

The interpretive trail Richardson manages has a steep section that does not seem to have an erosion problem, but gets slick when muddy creating a safety issue. Installation of a hand rail in this section is the proposed solution (Figure 4).

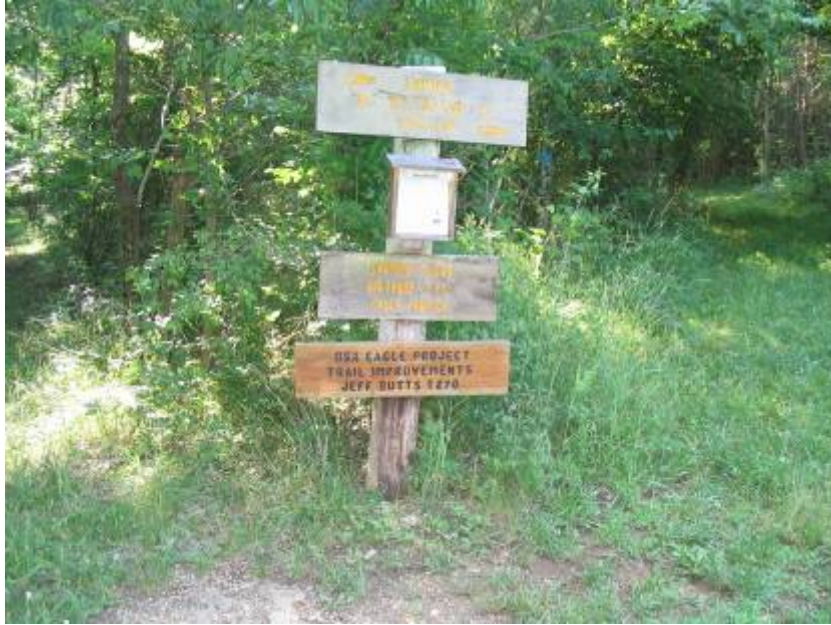
Figure 5. Taylorsville Lake, KY. These signs indicate the level of success the COE park manager has achieved in using volunteers to construct and maintain the interpretive trail.

The other challenge on trail construction and maintenance is the financial one. In an era of declining manpower and budgets, the maintenance of interpretive and hiking trails generally becomes low priority. Richardson has been successful in using volunteers such as Boy Scout troops and the general public on National Public Lands Day activities to accomplish an estimated 90% of the approximately 3-mile interpretive trail's construction (Figure 5).

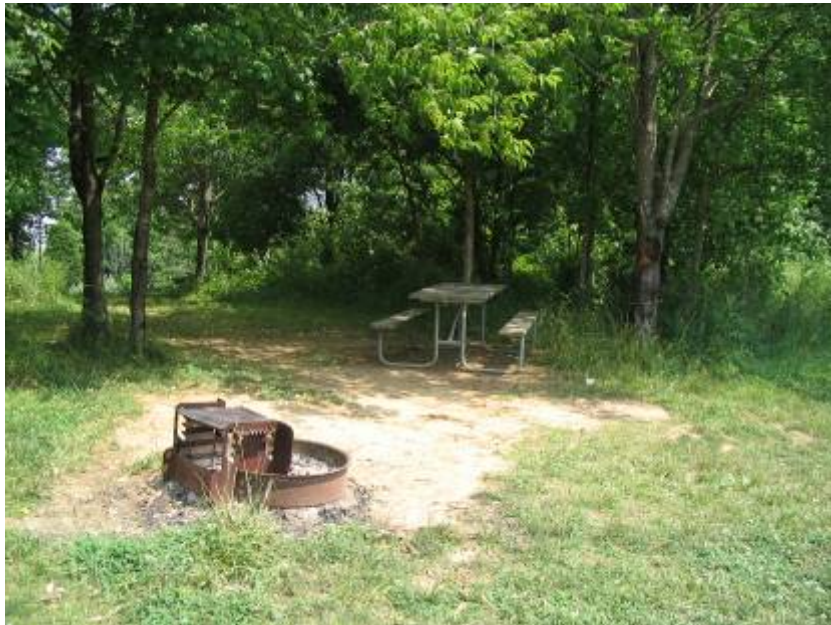
Figure 6. Taylorsville Lake, KY. This Taylorsville Lake State Park campsite is classified as a “primitive” site at Possum Ridge Campground and does not have a hardened impact pad. Note the soil compaction and loss of vegetation.

Pharis has the luxury of managing a new campground completed in 2000 with hardened impact areas, so he has not experienced problems with those sites. He did mention that the only impacts that he could envision to date would be on the few primitive sites they have. Indeed, during the site visit it was noted that soil compaction and loss of vegetation have occurred on those sites (Figure 6).

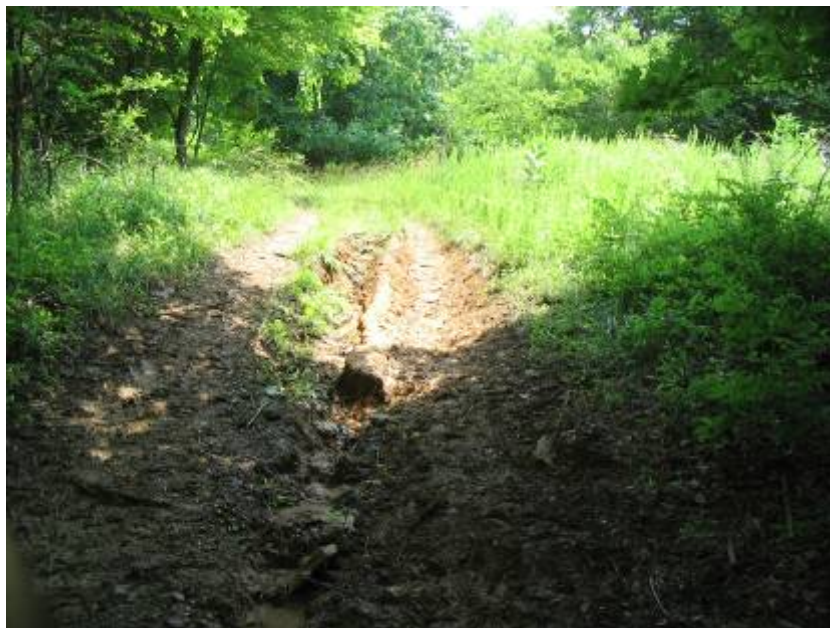
Pharis said that the main impacts on the trail have resulted from horse use in damp conditions (Figures 7-10). He also noted that severe erosion has occurred in several locations where the trails may have up to a 60% slope. He indicated that in some areas it is currently difficult to distinguish the original trail from new trails that users created to bypass deteriorated trail sections.

Figure 7. Taylorsville Lake, KY. Erosion on portion of the trails at Taylorsville Lake State Park, Possum Ridge area. This trail has been heavily impacted by horses.

Pharis has major plans to address the trail problems. Over the next eighteen months he hopes to resurface and rejuvenate the trail and change routes to make them more user friendly. This includes additions of berms and water bars to control water flow, incorporating winding descents with a maximum 15 % slope. He intends to mulch the surfaces. He has access to KY Department of Transportation surplus telephone poles to use for trail construction materials. Pharis also hopes to establish access trails

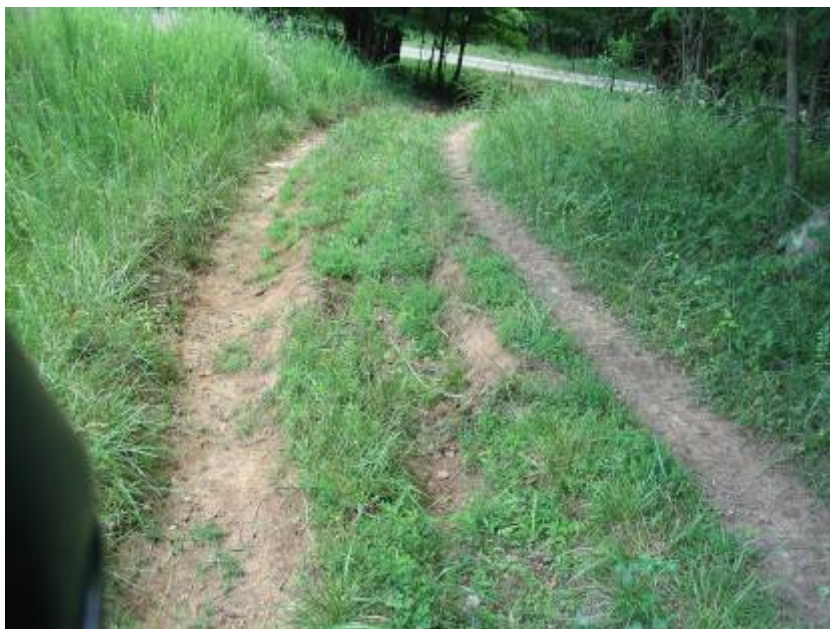
Figure 8. Taylorsville Lake, KY. View of a section of trail at Taylorsville Lake State Park, Possum Ridge area, which has been heavily impacted by horses. Although this appears to be a road for vehicle traffic, it is actually the original trail with a parallel new trail created beside it to avoid ruts in the original.

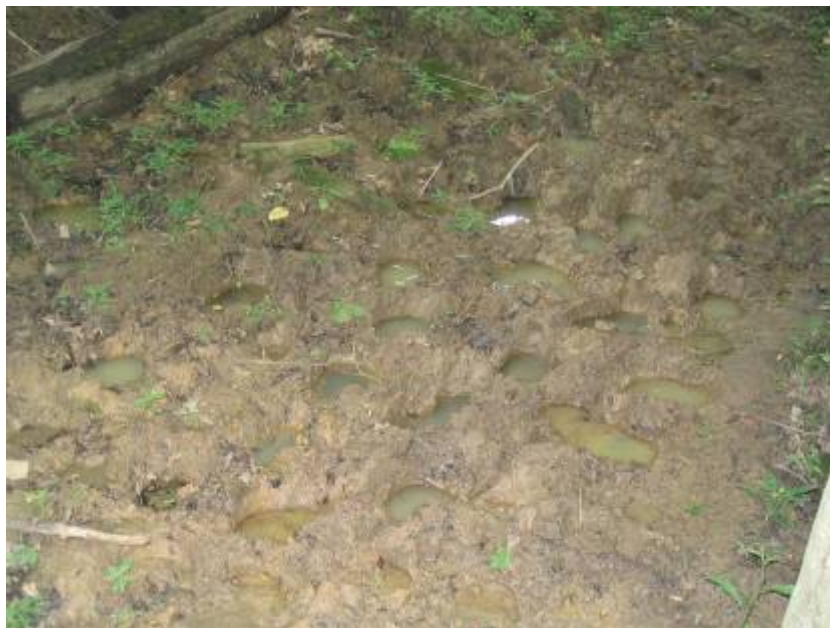
Figure 9. Taylorsville Lake, KY. Section of the trail at Taylorsville Lake State Park, Possum Ridge area. This view of standing water in hoof prints is typical of wet section of the trail, and predicted by the USDA soil survey for Spencer County's Recreational Development table that warns of moderate to severe limitations for all types of recreational facilities on Eden, Faywood, and Nicholson soils due to factors such of slope, slow percolation, and the amount of clay (USDA, 1986)

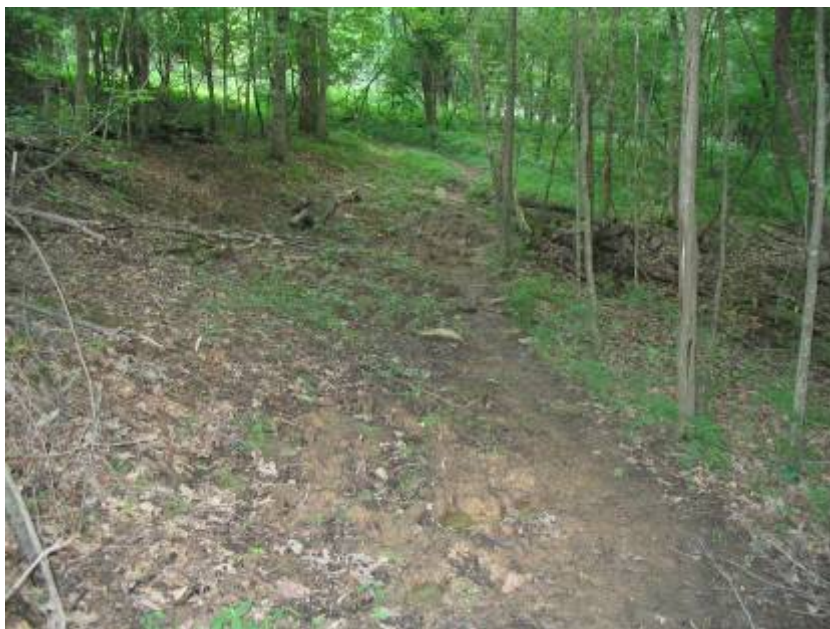
Figure 10. Taylorsville Lake, KY. Section of the trail at Taylorsville Lake State Park, Possum Ridge area. This portion of the trail stays wet – note standing water in hoof prints in the foreground. Also note that many of the hoof prints are to the left of the established trail, presumably created by riders trying to bypass the mud of the original trail. This photo was taken on June 14, 2005, when there had been only 1.34 inches of rain in the previous 24 days (0.80 inches of rain had fallen on June 12)

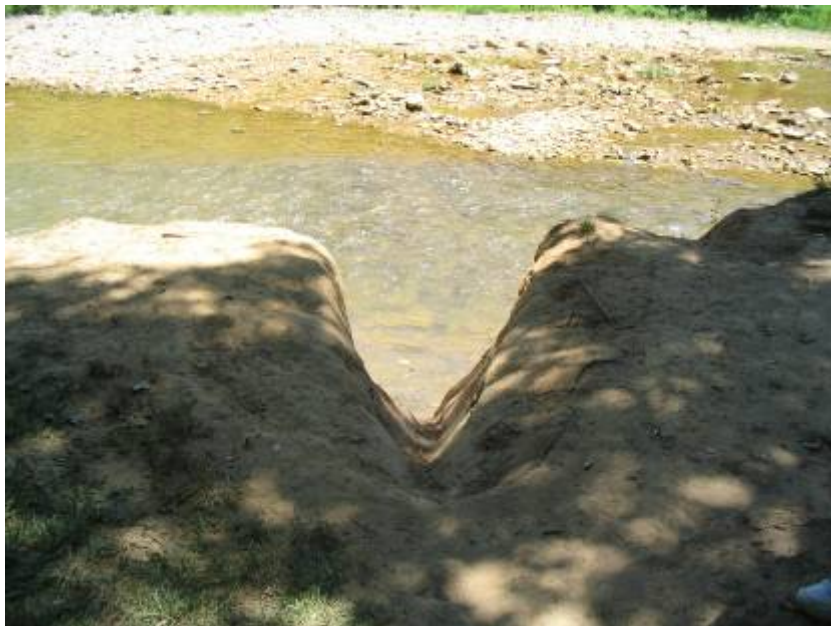
Figure 11. Otter Creek Park, KY. “Mudslide” cut into the bank along Otter Creek. Users splash a bucket of water in the cut to make it slick enough to slide down it into the creek

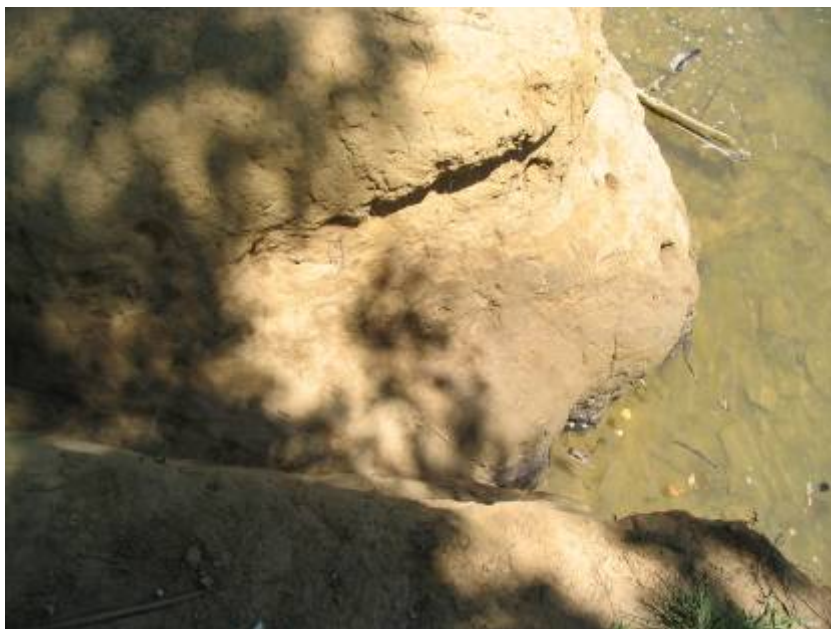
Figure 12. Otter Creek Park, KY. View of a mudslide created as access to the creek. The park naturalist has used education to slow the former proliferation of mudslides, and only one was active in July 2005

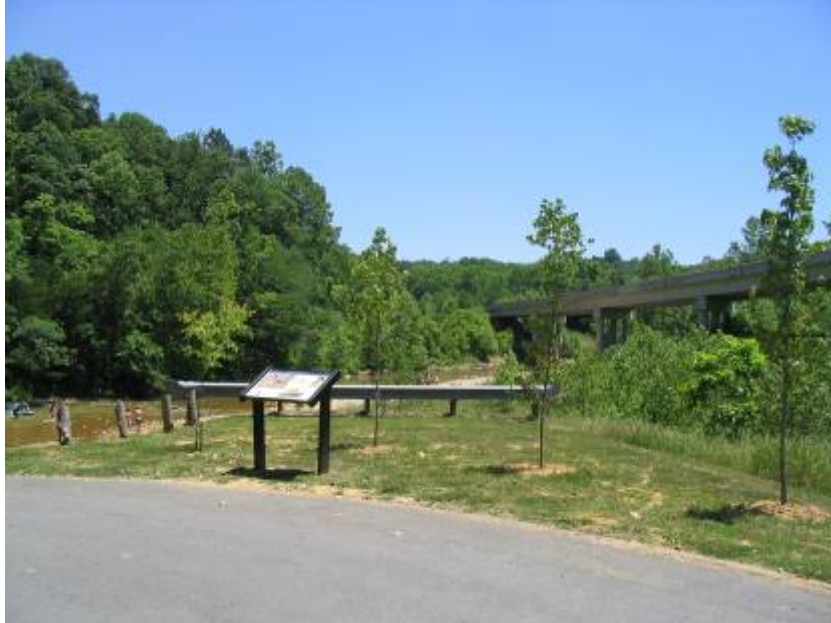
Figure 13. Otter Creek Park, KY. Small trees planted between the guardrail and the roadway have effectively stopped cars from pulling into the grassy area, where soil compaction and loss of vegetation due to the vehicles had been a problem

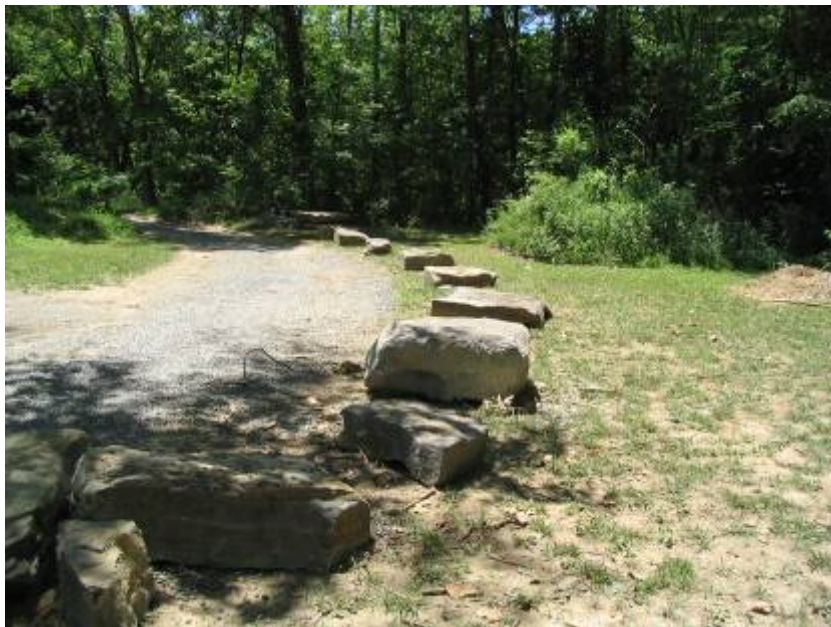
Figure 14. Otter Creek Park, KY. Large rocks from a nearby road cut used as natural barriers to keep vehicles out of the grassy picnic area

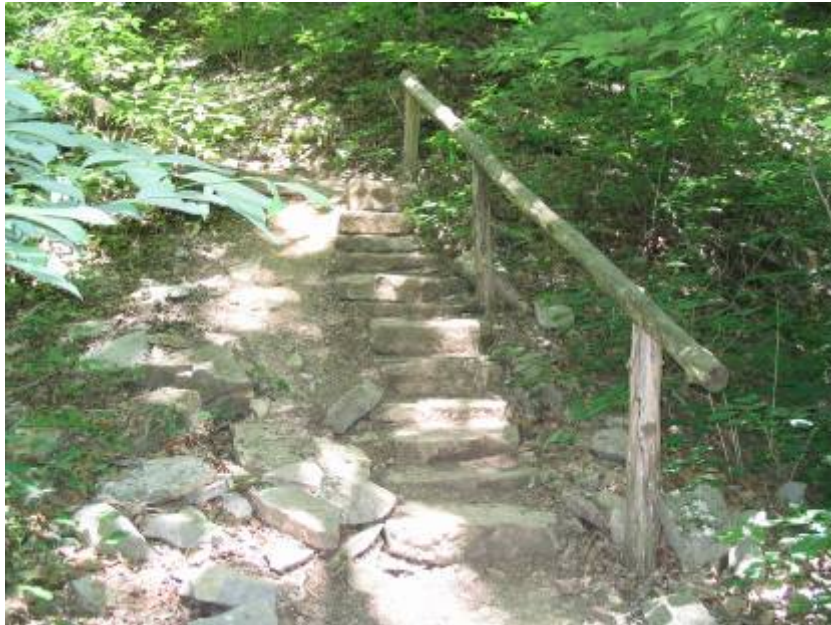
Figure 15. Otter Creek Park, KY. Steps placed on steep sections of trail can prevent erosion problems and provide a safer tread for hikers. This section of trail has steps made from rocks placed approximately seven years ago

Lewis had several examples of trails step construction on the trail to Morgan's Cave. A segment of the stairs was constructed with rocks approximately seven years ago (Figure 15). Another section was jack-hammered out of a large boulder about 15-20 yrs ago, which he said would probably never be done today due to fiscal constraints (Figure 16). Another type of step was constructed from cedar tree trunks (Figure 17), while the newest section of steps was made about five years ago with cedar tree sections and white gravel treads (Figure 18). An old timber section was still in good condition after nearly 15 yrs old because it was in a dry portion of the trail that receives partial sunlight (Figure 19). Besides the trail steps, along this trail Lewis pointed out some social trails. A persistent area of social trails is that leading to the top of Morgan's Cave, where the public wants to get on top of the cave to see this geologic feature from another angle (Figure 20).

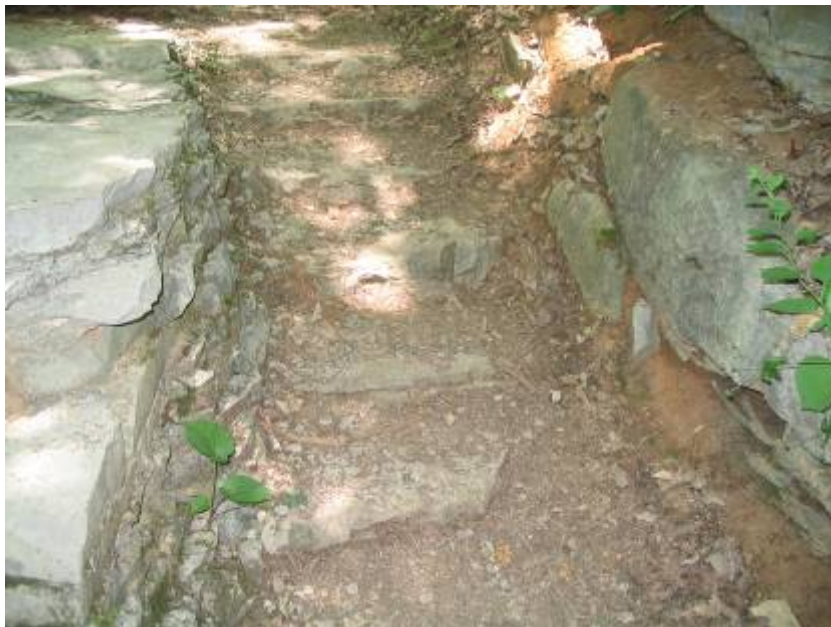
Figure 16. Otter Creek Park, KY. Steps on this section of trail were jack-hammered from an existing boulder in the trail's path about 15 years previously

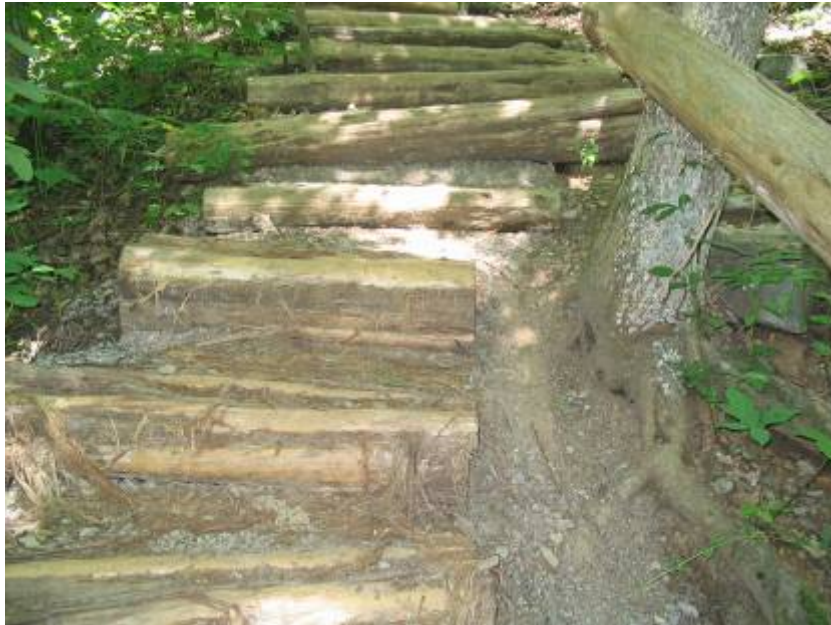
Figure 17. Otter Creek Park, KY. An old section of trail with steps made from cedar trees

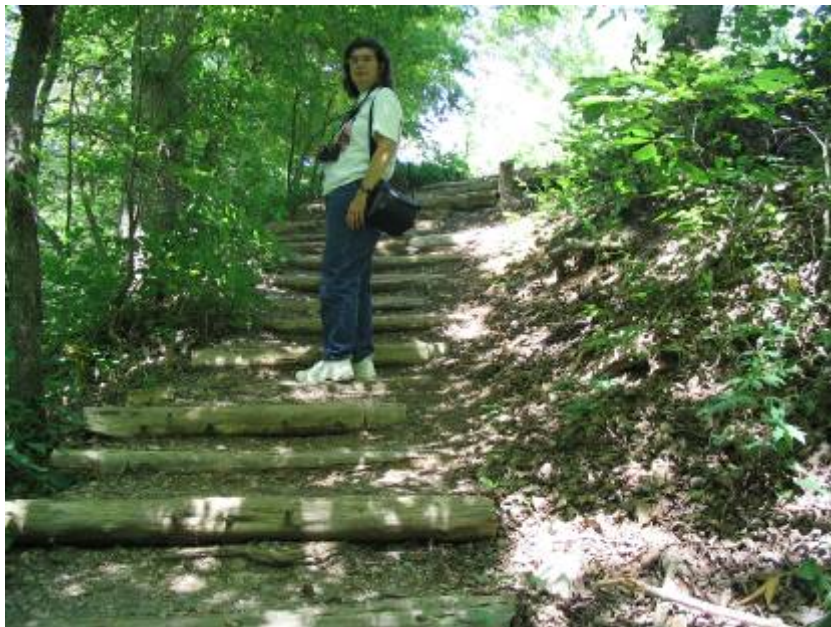
Figure 18. Otter Creek Park, KY. Steps newer than in Figure 17, placed using sections of tree trunks and gravel treads that have been in place for about five years

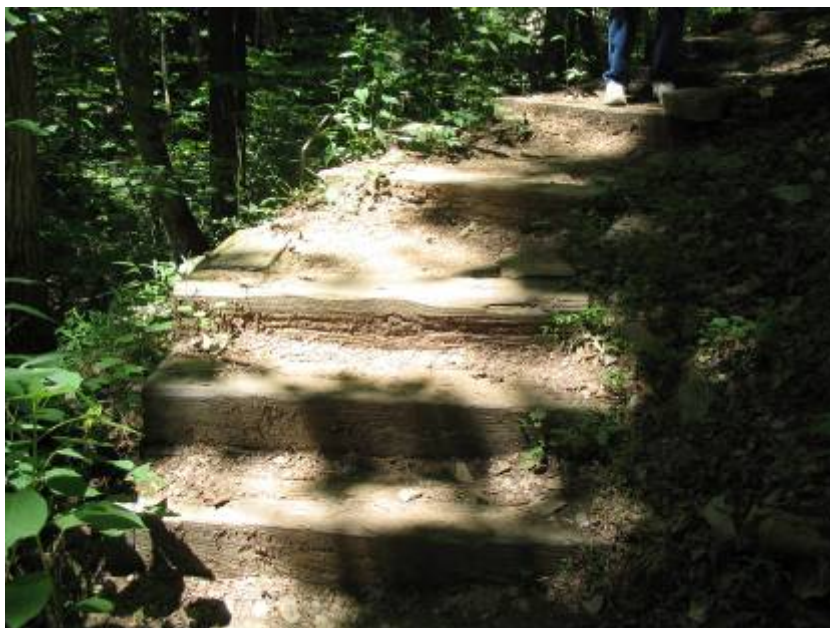
Figure 19. Otter Creek Park, KY. Trail steps made with timbers that have been in place for approximately 15 years. Since this is a dry section of trail and receives some sunlight, the timbers have lasted much longer than a typical five-year life expectancy in shaded, damp conditions

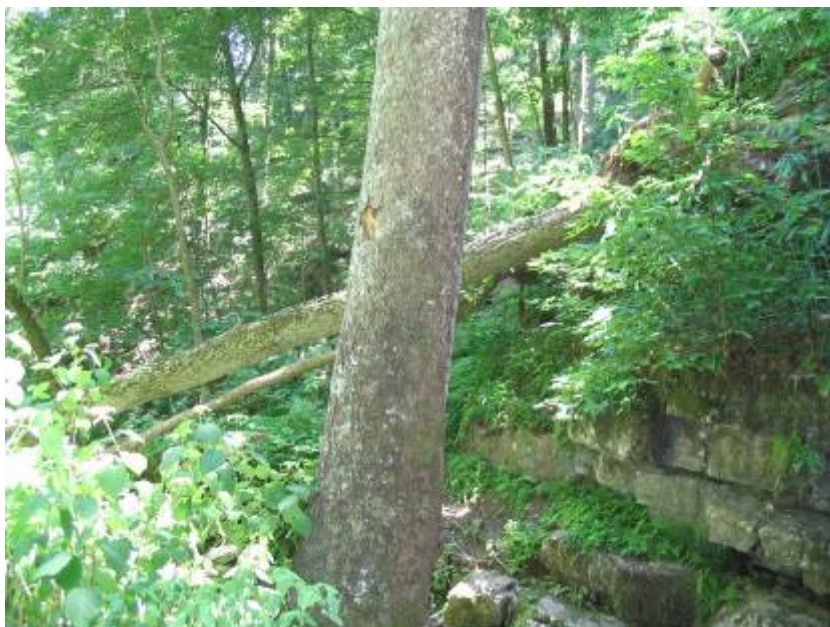
Figure 20. Otter Creek Park, KY. Visitors create new trails for their convenience which the park naturalist described as “social”, “rogue”, or “volunteer” trails. Examples are social trails established because visitors are determined to get to the top of the mouth of Morgan’s Cave, a significant geological feature in this park. This photo shows where Mother Nature succeeded where the park naturalist could not to close traffic on a social trail -- a fallen tree blocked the path

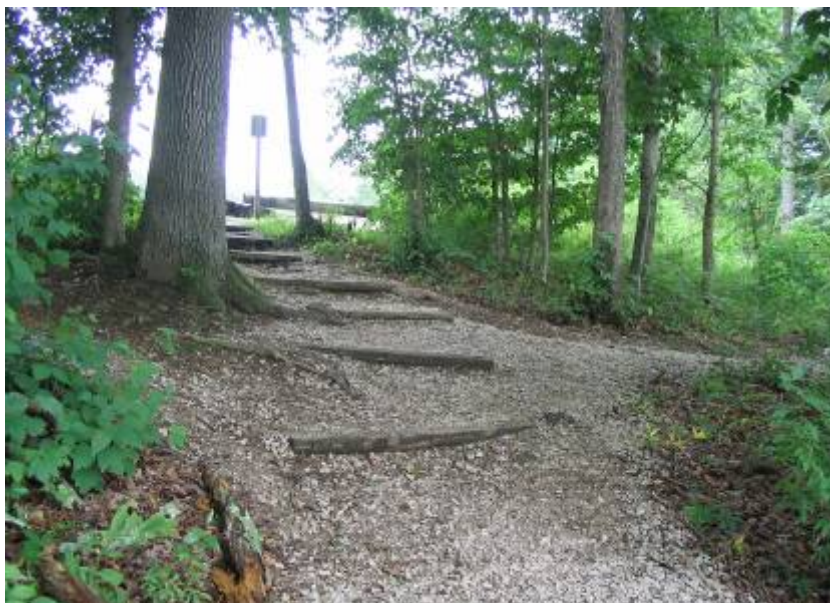
Figure 21. Cave Run Lake, KY. This trail to picnic sites in the COE's Stoney Cove Recreation Area utilizes timber water bars and gravel to slow erosion. Park Manager Barnum notes that "the selection of crushed stone sizes to harden problem areas along trails depends upon the gradient of the trail segment and underlying soils. Class I sand (limestone chips) is far superior as a walking surface (packs well, lays flat and is quiet); however, it is unsuitable as a hardening material along steeper sections of a trail. Larger stone, such as No. 57 or No. 610 are heavier and resist erosion better. But the angular pieces of larger stone do not pack well, are noisy to walk over and tend to roll under foot"

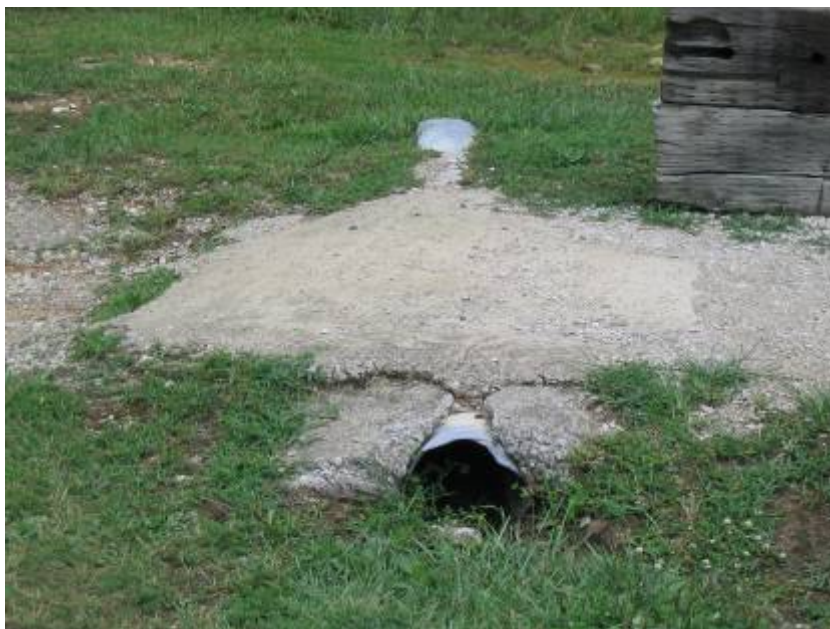
Figure 22. Cave Run Lake, KY. The COE manager uses concrete caps to keep shallow trailhead culverts from floating out of place since it sits on solid bedrock due to shallow soils in the area. The concrete cap provides a resilient walking surface and keeps the culvert covered and in place

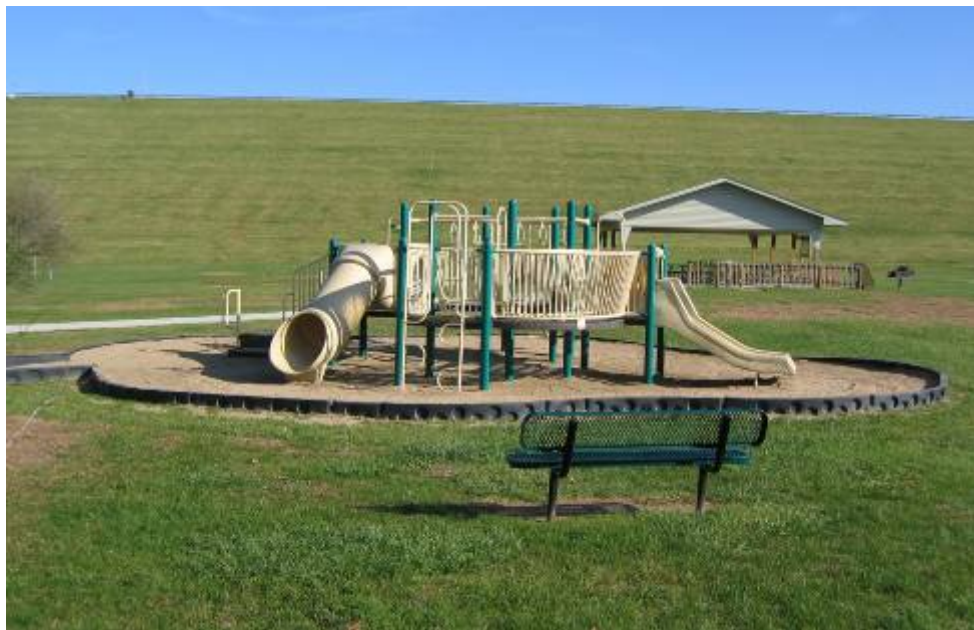
Figure 23. Cave Run Lake, KY. Playground equipment in the COE's Tailwater Recreation Area has a sand-filled impact zone that reduces soils compaction and muddy conditions, and also provides fall-protection for users. Commercially available heavy rubber pads made of shredded tires are provided at selected locations within the impact zone to prevent depressions in the soil that would hold water, and to provide protection in possible fall zones

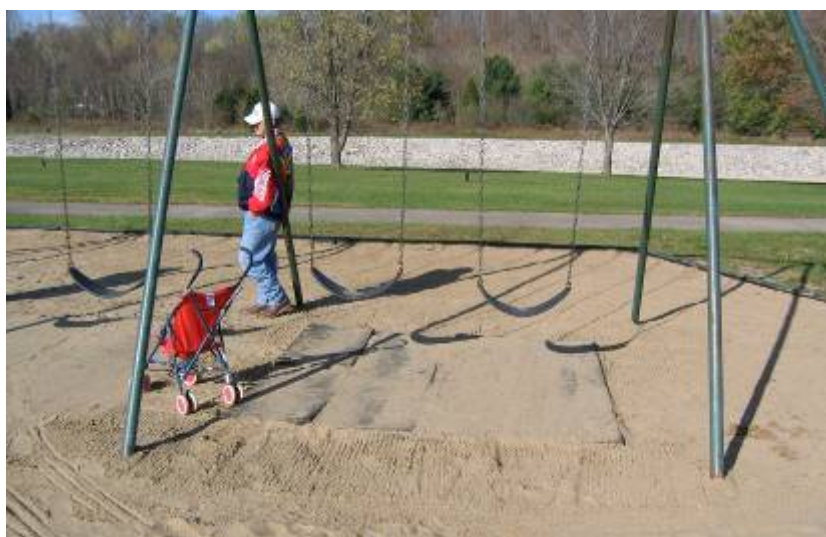
Figure 24. Cave Run Lake, KY. The COE manager uses commercially available rubber pads, buried semi-flush with the ground, to prevent "dips" of compacted soil that hold water directly underneath swings. A specially formulated 2-part glue is used to fasten the pads to a treated wood base that is imbedded in the sand. This installation method keeps the rubber pads in place, and avoids use of metal fasteners that could create a safety hazard

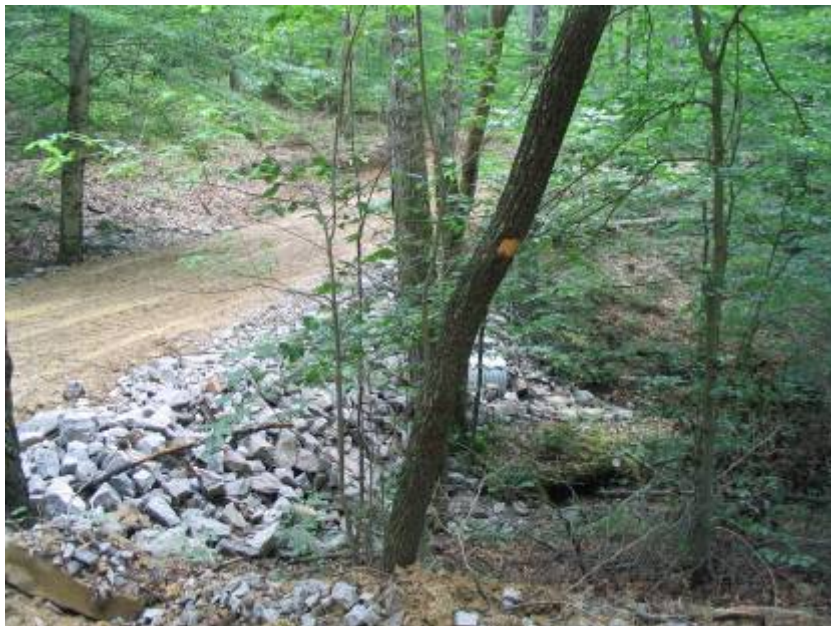
Loomis has a lot of experience with trail erosion, and noted that "ruts become little canyons." Where lots of horse traffic will occur, wet areas need underdrain. During the site visit Loomis discussed several techniques he would use during trail upgrade, to include use of geosynthetic materials such as Tri-lock block and geocell. He told about using two or three 12-inch culverts in one area the previous year and rains popped them right out, so Tri-lock block will be used this time instead. He noted that Tri-lock with riprap on the ends of drain crossings will last a lifetime (Figure 25-26). This author was able to return two

Figure 25. Cave Run Lake, KY. USFS's Sheltowee Trace Trail, July 2005. Culvert placed, with riprap on both sides of the trail where trail crosses drain

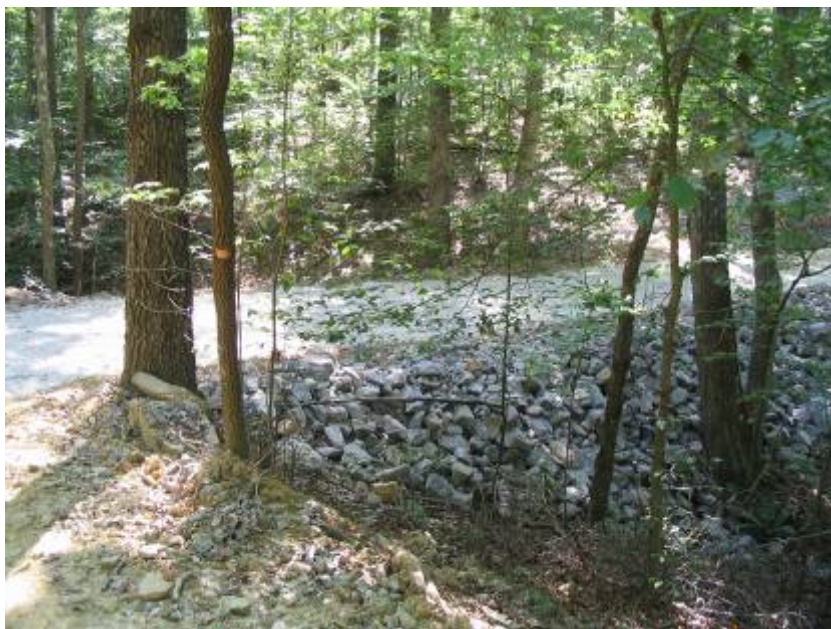
Figure 26. Cave Run Lake, KY. September 2005, view of finished section of trail that crosses drain shown in Figure 25. Tri-lock block has been placed, topped with gravel. USFS representative Loomis indicates this type of repair incorporating Tri-lock block and riprap "will last a lifetime"

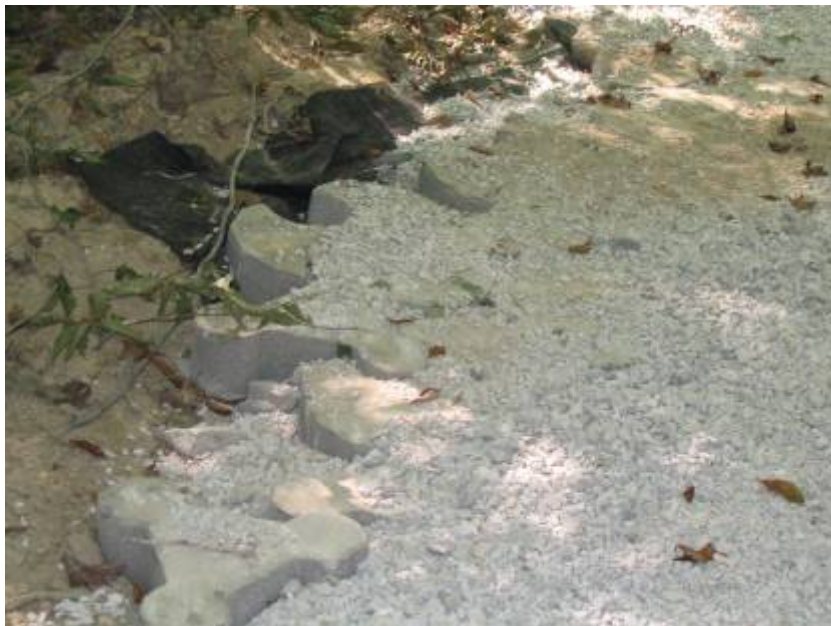
Figure 27. Cave Run Lake, KY. September 2005, view of rehabilitated section of Sheltowee Trace trail. The exposed trail edge shows materials used in the rehab: geotextile fabric underneath a layer of Tri-lock block, with top layer of gravel

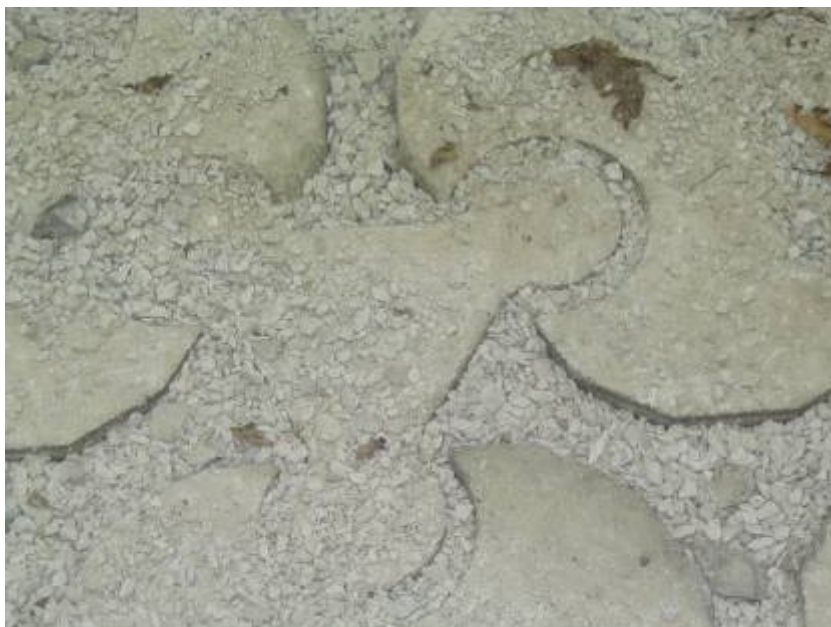
Figure 28. Cave Run Lake, KY. Close up view of Tri-lock block placed on the trail. “Tri-lock is a system of pre-cast concrete blocks made up of two components: a ‘lock block’ and a ‘key block’. Each is keyed into two other components for stability and integrity. For ease of installation, the blocks are typically installed in dry conditions by hand on a specially engineered filter fabric” (Hanson,)

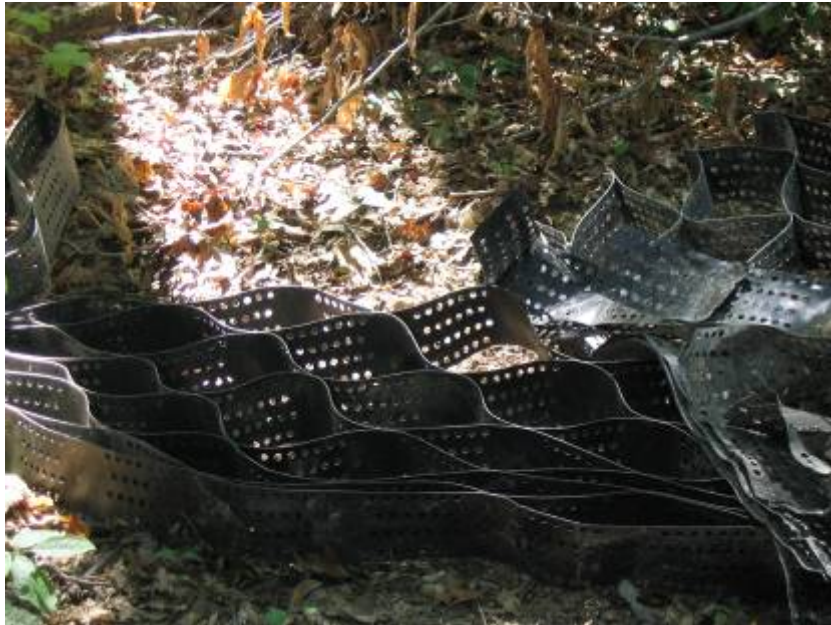
Figure 29. Cave Run Lake, KY. View of geocell – a flexible geosynthetic mat – before placement on the Sheltowee Trace trail for erosion control

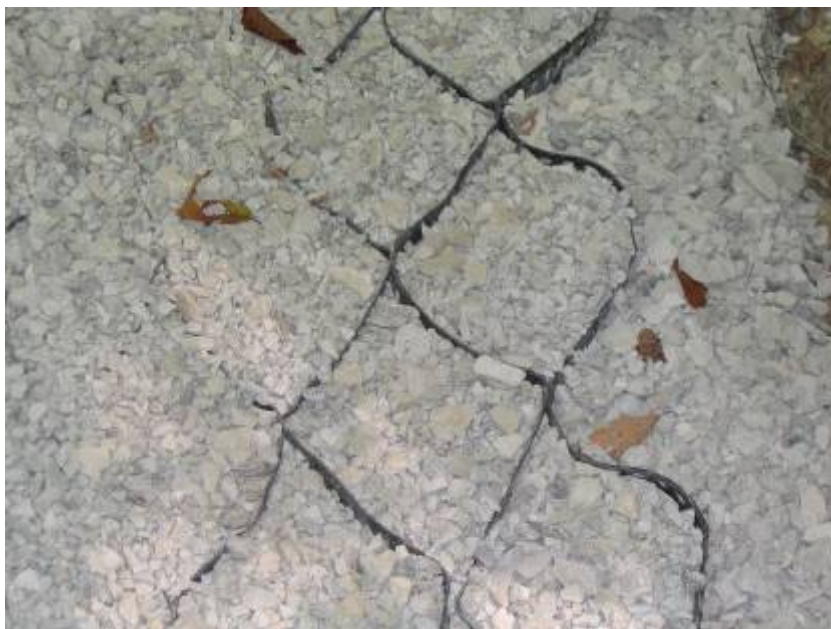
Figure 30. Cave Run Lake, KY. View of geocell after placement on the edge of a Sheltowee Trace section for erosion control

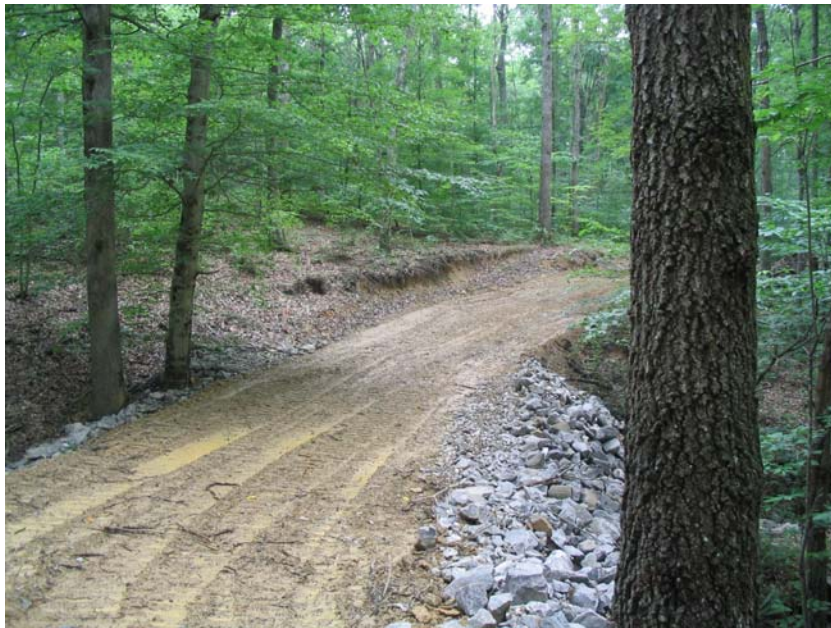
Figure 31. Cave Run Lake, KY. July 2005, Sheltoewe Trace Trail. View looking south. Note the bank on the left side of the trail

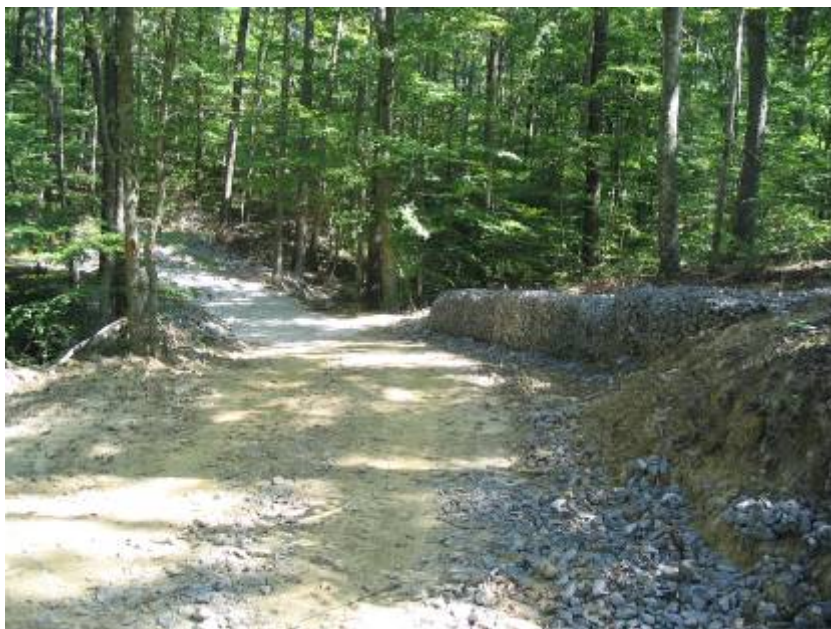
Figure 32. Cave Run Lake, KY. View looking north. Note the gabion placed for erosion control of the bank shown in Figure 27 (right side of the trail in this photo)

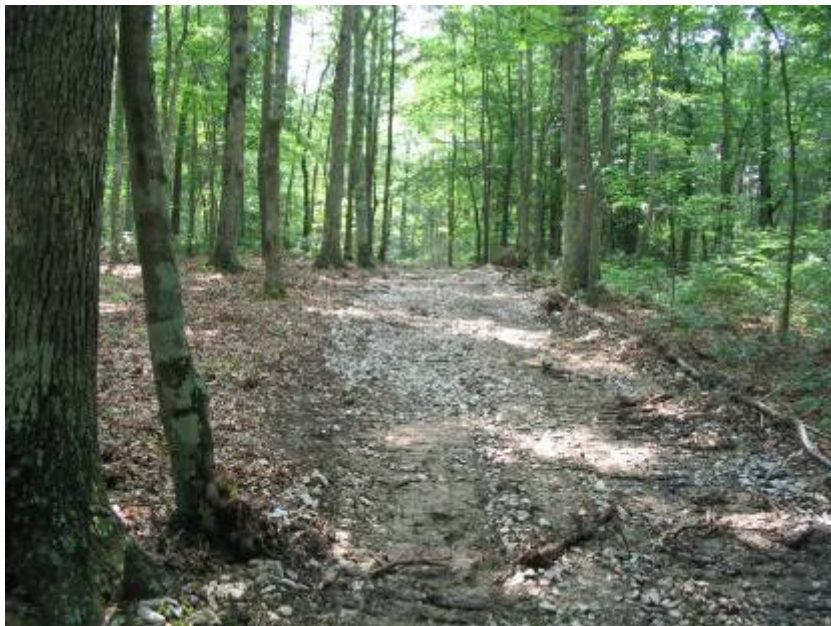
Loomis noted that the initial trail construction and renovation looks like a road, but showed areas on the Caney loop that were built with a dozer in 1991 but have grown in to look very natural (Figures 33-34). On the Caney loop he also pointed out some log water bars put in by mountain bikers as he directed, but now people are going around them instead of over them.

Figure 33. Cave Run Lake, KY. July 2005, Sheltowee Trace Trail rehabilitation. Note dozer tracks. Because hand labor is so slow and cost prohibitive, the USFS uses small dozer for initial construction and major trail rehab to clear and level trails. The addition of gravel to the tread gives an initial appearance of “a small road” in the word of USFS representative Loomis

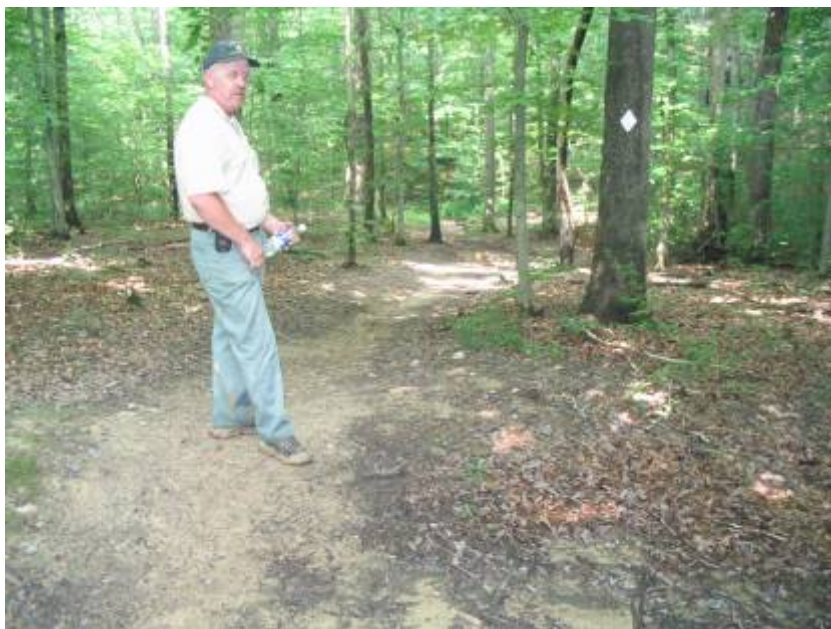
Figure 34. Cave Run Lake, KY. July 2005, view of a section of Caney Trail that was initially cleared by the USFS with a small dozer in 1991. In 1991 this trail looked similar to the view in Figure 29, but vegetation has grown into restore the natural look
