# ROGUE RIVER WATERSHED COUNCIL

## RIVER MILE 5.6 RESTORATION PROJECT – CHALLENGE PARTNERSHIP ELK CREEK PROJECT

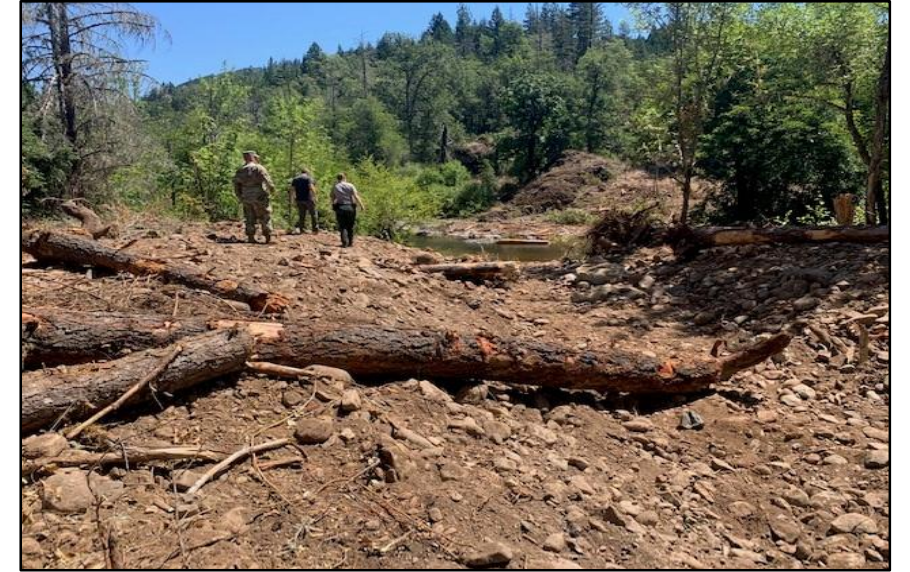
*Side channel excavation with large woody debris. Logs donated by BLM and Hancock Timber- salvage from 2018 Miles wildfire that burnt 200+ ac in Elk Creek.*

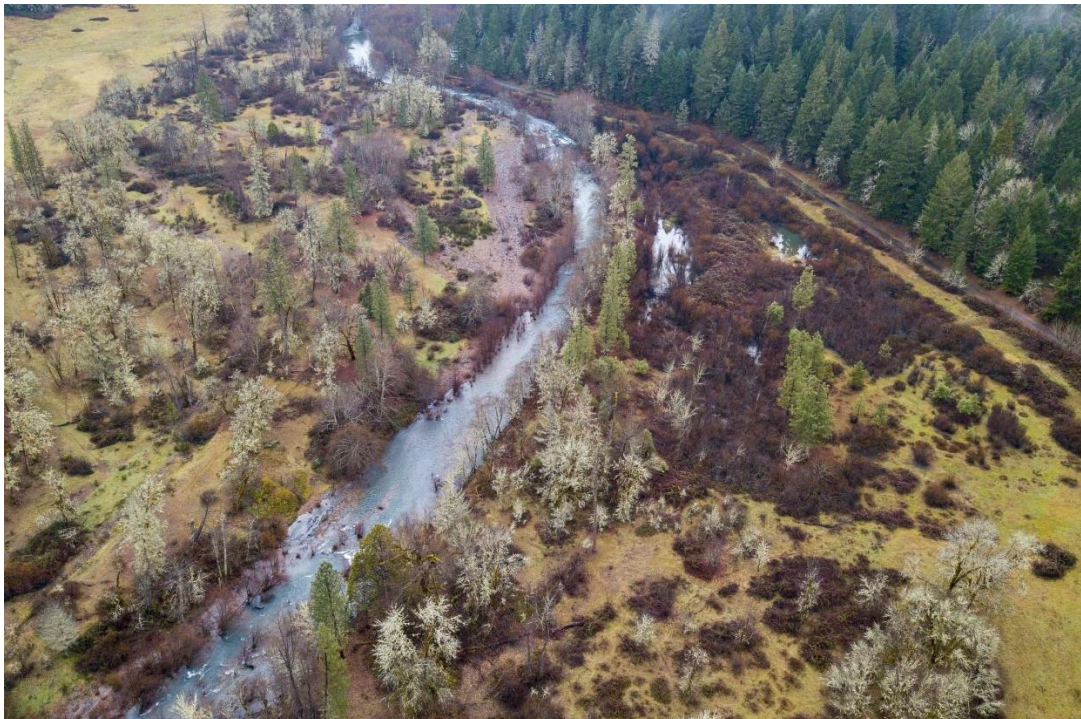
Aerial view of downstream portion of the project site

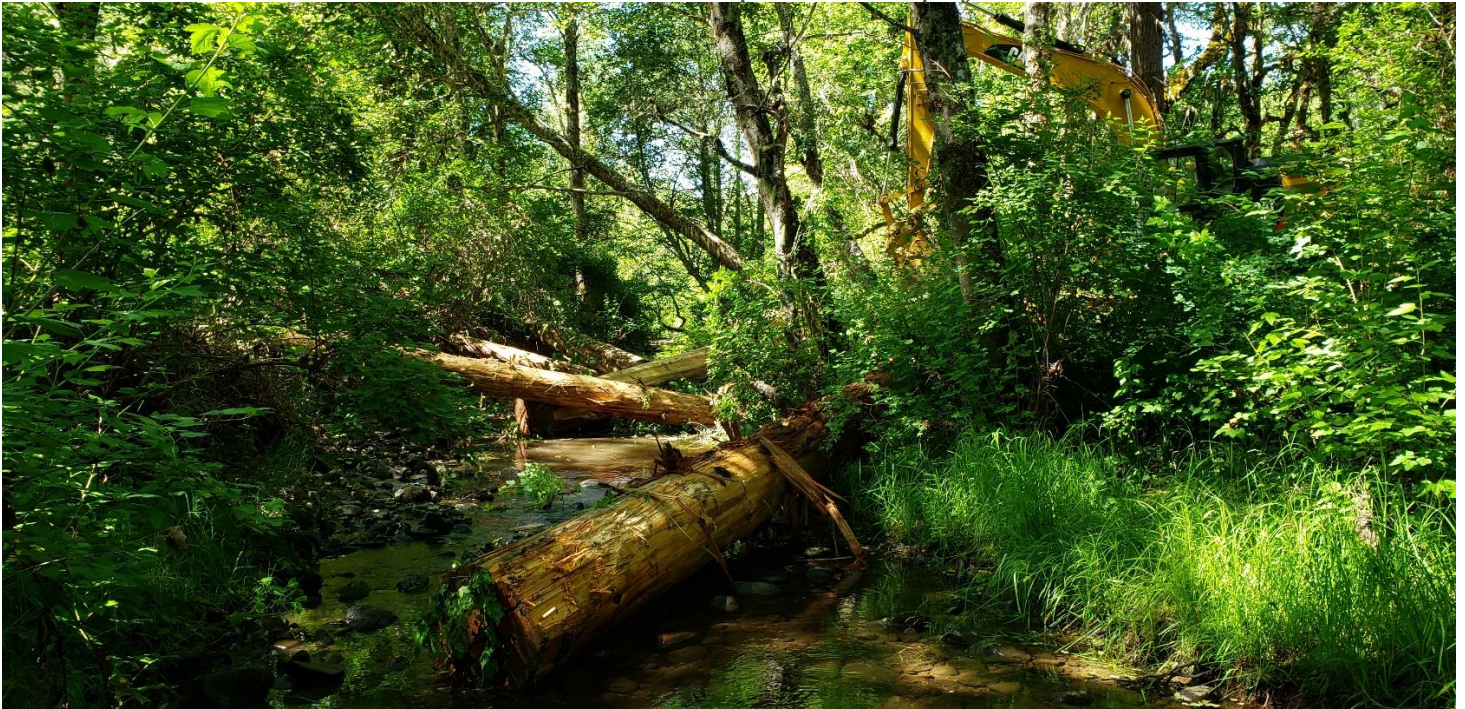
Large woody placement in side channels

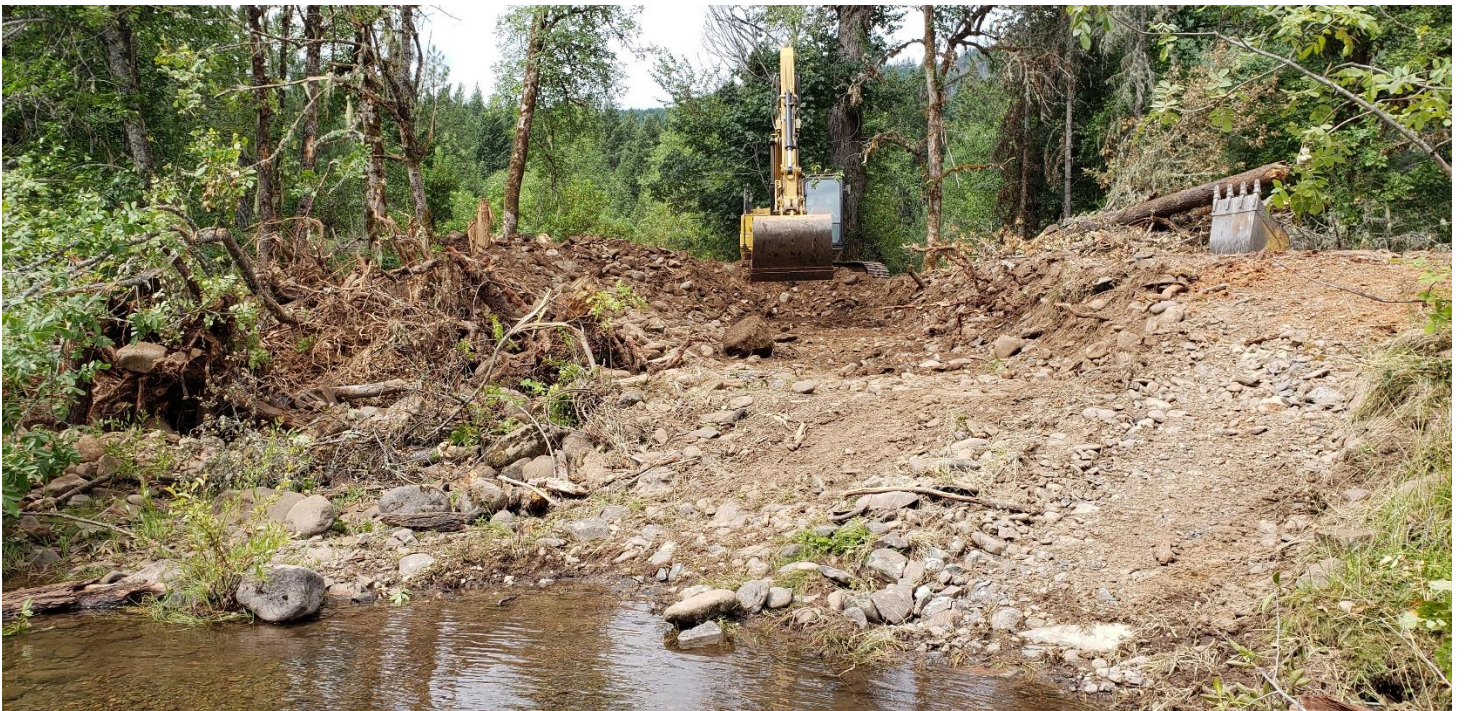
Excavating the artificial berm at inlet of side channel

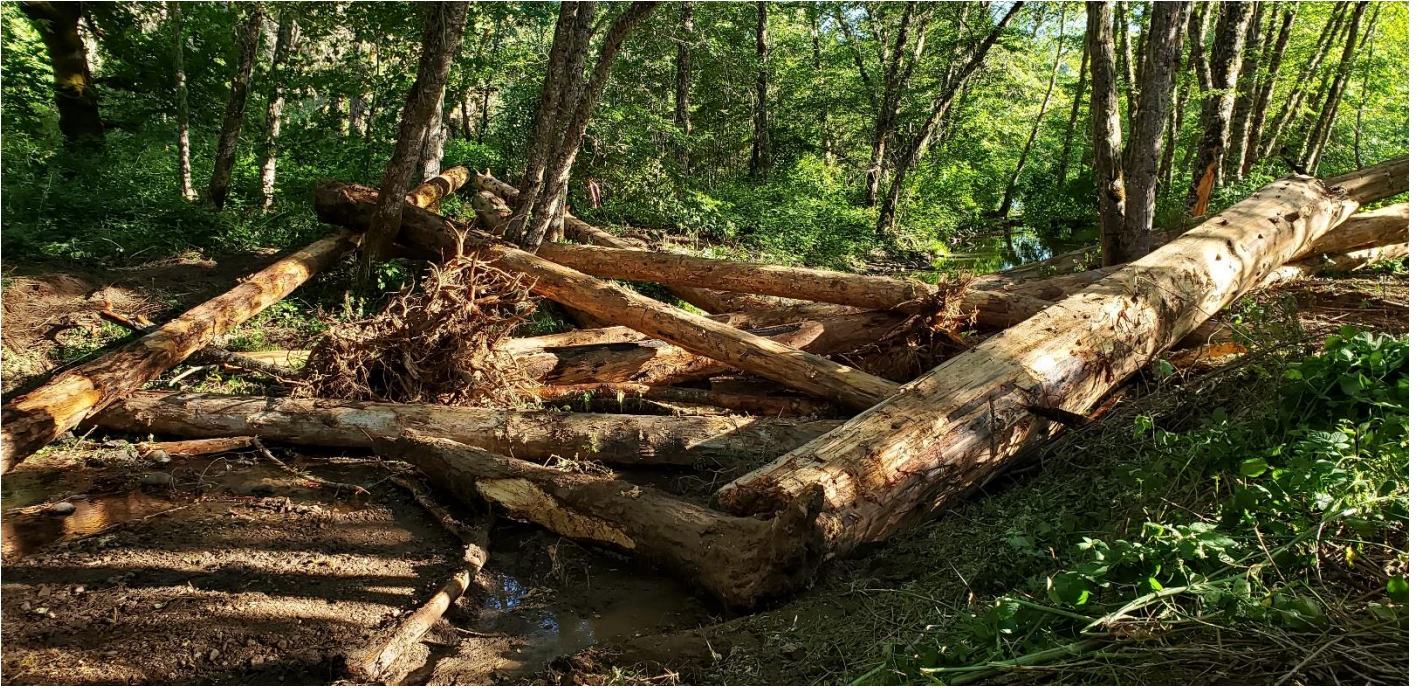
Large wood placement, finished product
