Condition Assessment Quick Guide for Gravel Roads

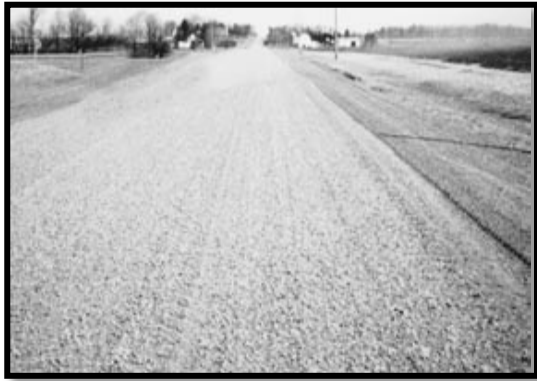
USACE FCI Score	OCA Grade	PASER Score	Description	Images	
7 Excellent	A	5	<ul style="list-style-type: none"> • No distress. • Dust controlled. • Excellent surface condition and ride. • New construction—or total reconstruction. • Excellent drainage. • Little or no maintenance needed.

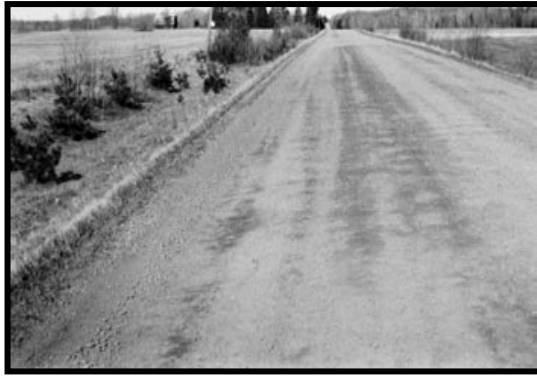
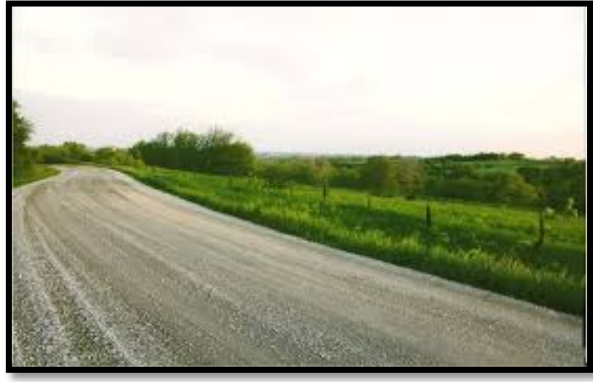
6 Excellent to Good	A-	4	<ul style="list-style-type: none"> • Dust under dry conditions. • Moderate loose aggregate. • Slight washboarding. • Recently regraded. Good crown and drainage throughout. • Adequate gravel for traffic. • Routine grading and dust control may be needed.

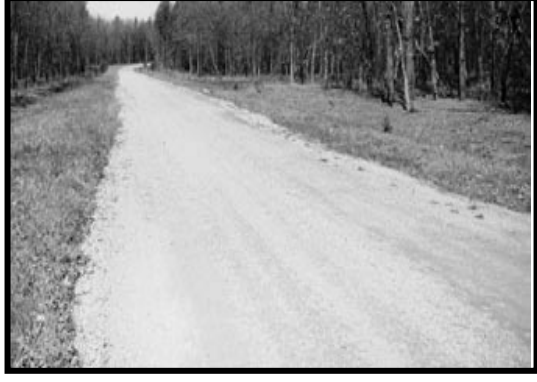
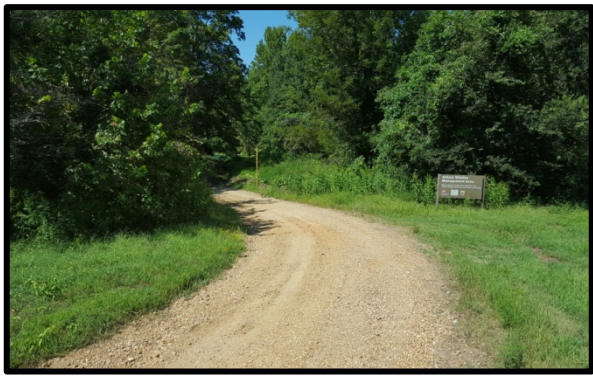
5 Good	B	N/A	<ul style="list-style-type: none"> • Good Crown (4-6") • Gravel layer adequate (5-6") • Isolated areas of washboarding. • Little to no ruts or potholes • Culverts clear and functioning properly • Routine grading and dust control needed.

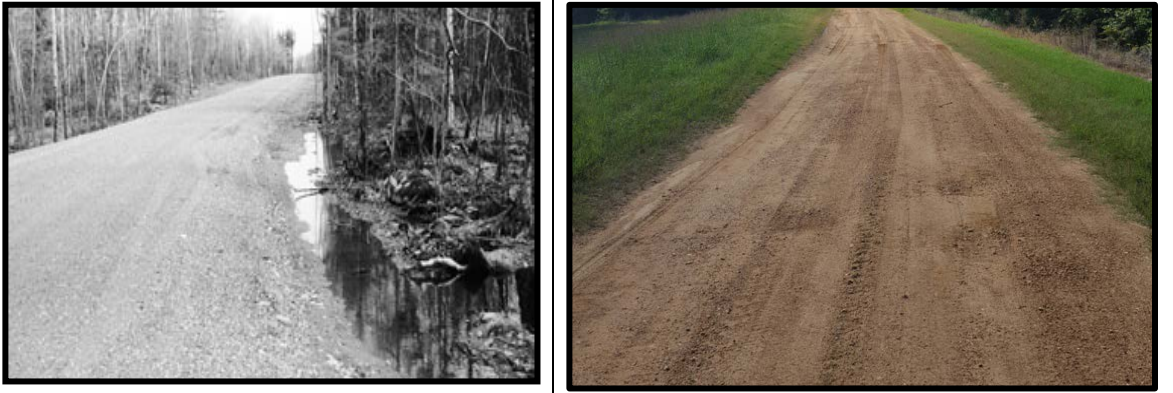
USACE FCI Score	OCA Grade	PASER Score	Description	Images
4 Good to Fair	B-	3	<ul style="list-style-type: none"> • Good crown (3"-6"). Adequate ditches on more than 50% of roadway. • Gravel layer mostly adequate but additional aggregate may be needed in some locations to correct washboarding or isolated potholes and ruts. • Some culvert cleaning needed. • Moderate washboarding (1"-2" deep) over 10%-25% of the area. • Moderate dust, partial obstruction of vision. • None or slight rutting (less than 1" deep). • An occasional small pothole (less than 2" deep). • Some loose aggregate (2" deep).

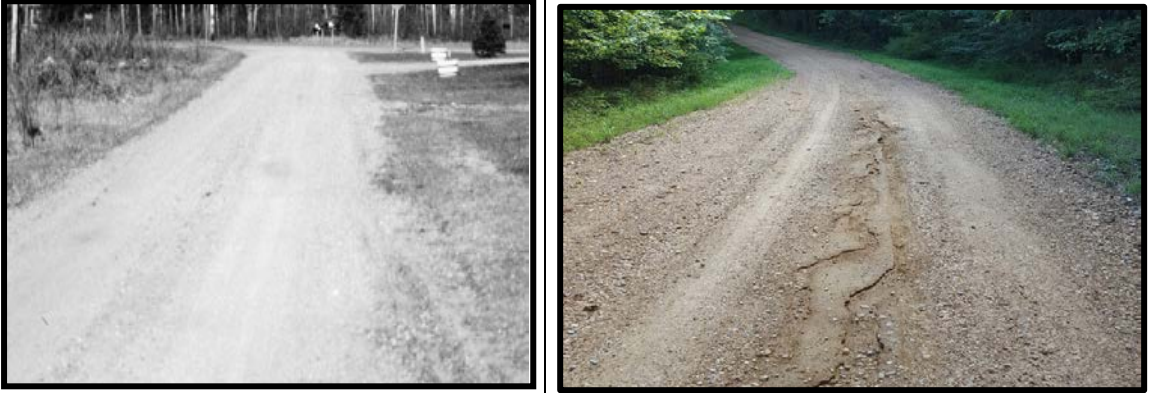
USACE FCI Score	OCA Grade	PASER Score	Description	Images
3 Fair	C	N/A	<ul style="list-style-type: none"> • Reduced roadway crown (2-3") • Adequate ditches about 50% of roadway with little overgrowth and/or erosion. • Less than 25% of area with little to no aggregate. Moderate loose aggregate (2-4" deep) • Light to moderate washboarding approx 3" deep. • Light rutting (2-3") in less than 10% of the area. • Shallow/small potholes (2" deep) over less than 10% of area. • Culverts contain some debris, but water flow not significantly impacted • Dust obscures visibility

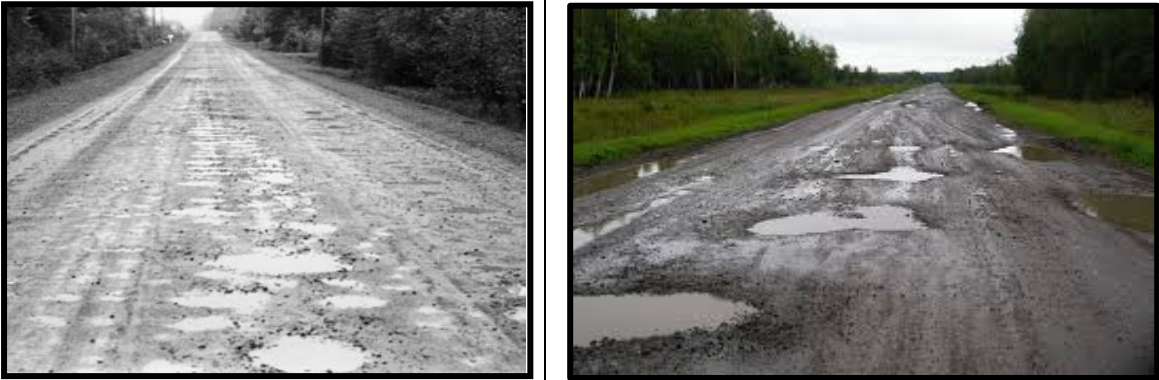
USACE FCI Score	OCA Grade	PASER Score	Description	Images
2 Fair to Poor	C-	2	<ul style="list-style-type: none"> • Little or no roadway crown (less than 3"). • Adequate ditches on less than 50% of roadway. Portions of the ditches may be filled, overgrown and/or show erosion. • Some areas (25%) with little or no aggregate. • Culverts partially full of debris. • Moderate to severe washboarding (over 3" deep) over 25% of area. • Moderate rutting (1"-3"), over 10%-25% of area. • Moderate potholes (2"-4") over 10%-25% of area. • Severe loose aggregate (over 4").
